# New England Rail Trail

## Trail Development Plans

Armidale – Black Mountain  
Ben Lomond – Glen Innes

## DRAFT REPORT

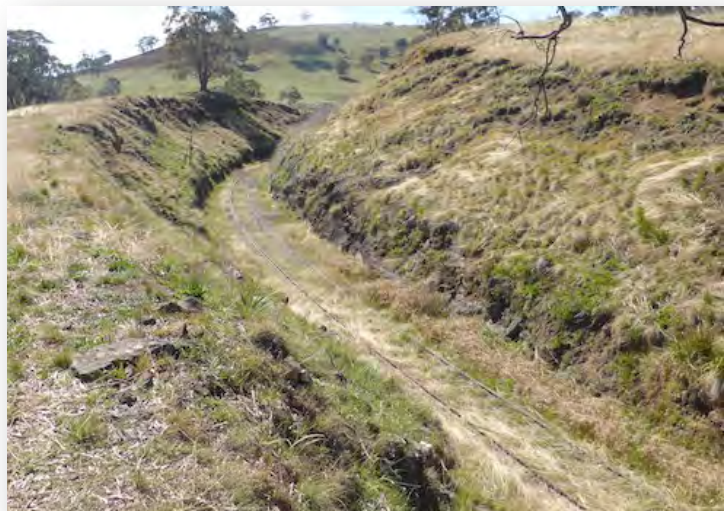
*The old drains of the many cuttings along the proposed rail trail will require attention to ensure they still perform the task of clearing water from the cuttings.*

Numerous culverts inspected during fieldwork were completely or partially block, thereby inhibiting the free flow of stormwater under and away from the railway embankment. Regular cleaning of blocked culverts is essential to avoid serious soil and water degradation problems.

Those sections of the railway formation which do have blocked culverts or dysfunctional drains should be attended to in the trail construction process, as allowing water to stand on the proposed trail surface or run down even a gentle slope is to invite surface damage followed by costly repairs.

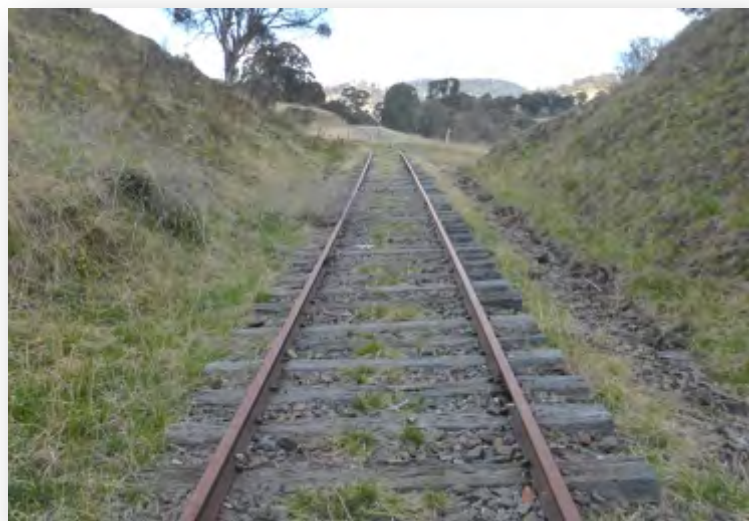
*A considerable amount of ballast still remains along the proposed trail route and must be removed in the trail construction process.*

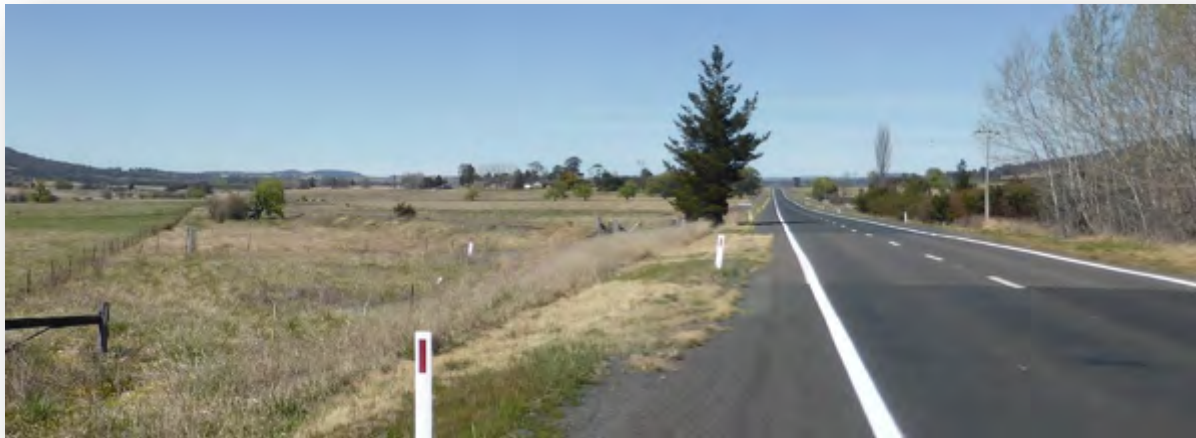
*Road crossings often present a challenge. Crossing the New England Highway will be a key challenge for this project.*

- ✚ Installation of signage on the rail trail (both sides of the road crossing) advising (or warning) of the upcoming crossing of the road. The recommended treatment is the installation of (either or both) "Give Way" (or "Stop" signs if it is a major road) and "Road Ahead" signs on both sides of the crossing. Where the chicanes are close to the crossing, "Give Way" signs should be included on the railings of the chicane;

- ✚ “Trail Crossing Warning Signage” on the road (both sides of the trail crossing) alerting road users of the upcoming trail crossing;
- ✚ Management access gates and chicanes (permitting access by legitimate trail users and authorised vehicles, such as emergency services vehicles and management vehicles) in certain locations. A technical drawing setting out the specifications for chicane gates can be found in Appendix 2, as well as a concept drawing and a photo of such a gate on the Lilydale Warburton Rail Trail in Victoria. Experience from other projects is that the chicane system needs to have a significant concrete surrounding as this minimises necessary maintenance mowing. The experience has been that grass can grow immediately around the timber posts and is difficult to mow using slashers. A wider concrete apron means no mowing immediately around the whole gating system. There are many alternative gating systems which could be used. Appendix 2 also includes a concept drawing and a photo of a different system in use on a recently opened section of the Brisbane Valley Rail Trail. Use of the trail by horse riders would require the addition of a horse step-over or cavaletti gate to allow horses access to the corridor if this design is used.

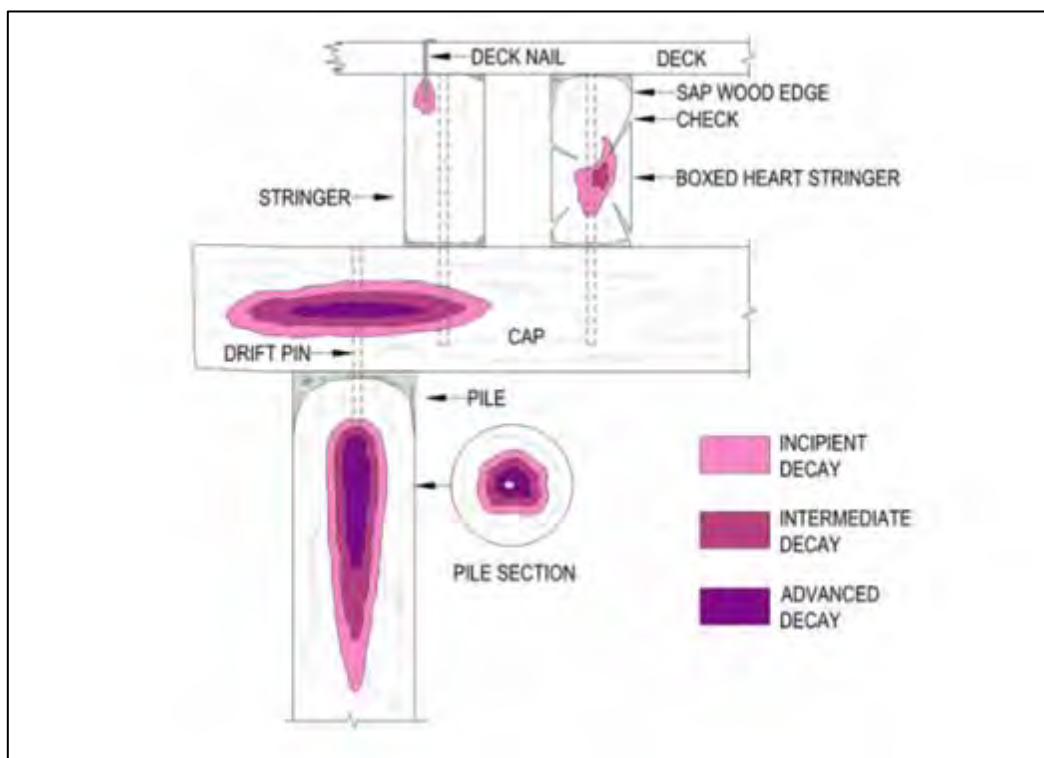
**Figure 3-2:** Shows the level of decay that occurs in timber due to the use of vertical fasteners. Vertical fasteners increase the rate of decay in timber as they allow moisture to travel down the fastener into the heartwood of the headstock (cap), girders (stringers), corbels and piles, therefore increasing the moisture content in the middle of these elements. The heartwood of a log element is less capable of breathing and expelling moisture than the sapwood that surrounds it, so vertical connectors funnel the moisture directly into the heartwood accelerating decay. Once the moisture content exceeds 22%, timber consuming fungi are activated and the decay process begins.

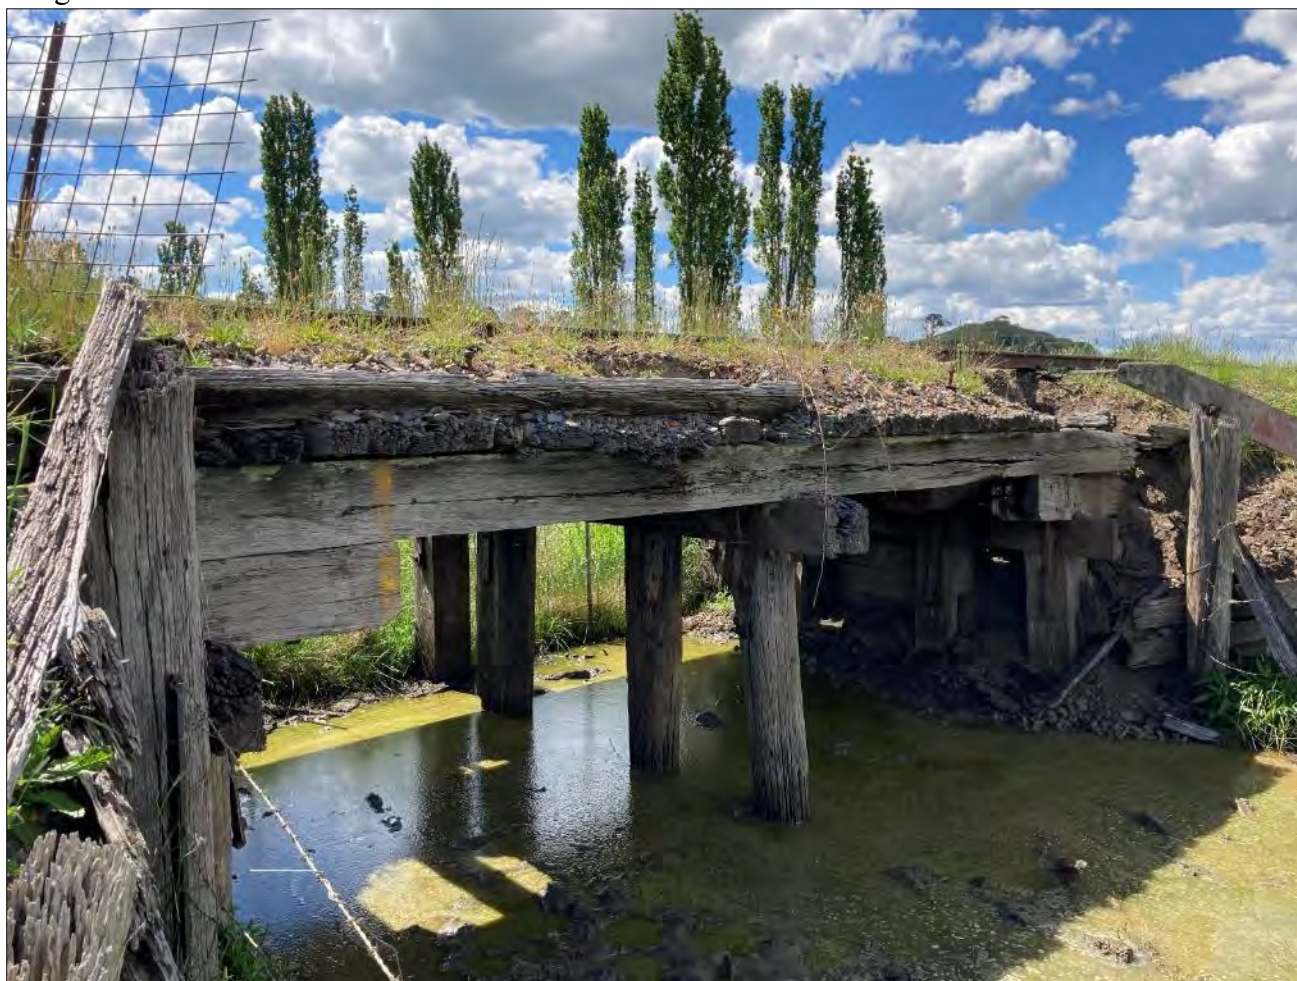
**Figure 4-1: View of Old Ben Lomond Rd Bridge from Abutment 1. The timber bridge is 2 spans long and approximately 8 metres long. At the time of inspection, the water was not flowing (boggy ‘spring’) and had a maximum depth of 0.5m. The wingwalls and backwalls have significantly deteriorated and no longer retain any of the approach fill material. Also note there is a fence located/attached on the left side of the bridge. Also note the horizontal crack on Girder 4 which is a key sign of internal decay and section loss causing the beam to fail under the deadweight of the bridge alone.**

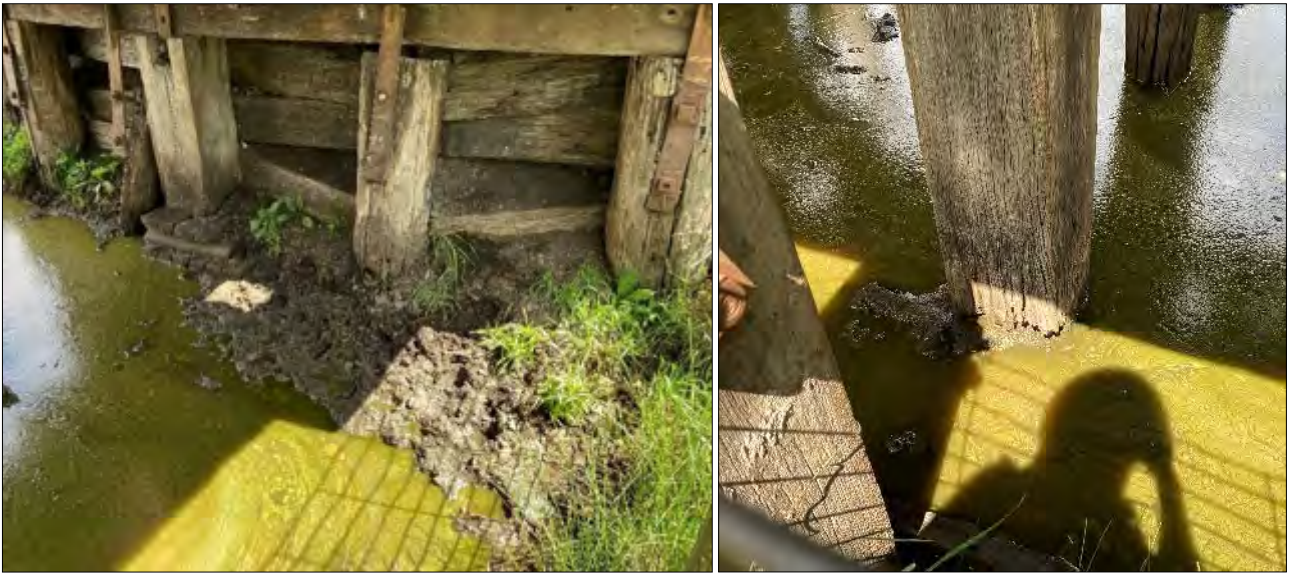
**Figure 4-2:** View of the timber abutments and pile. The bents comprise of 4 piles with significant deteriorated found and evident with timber packers placed under some piles (Pile 3 in the left-hand image above). Overall the timber bents were found to be in very poor condition with a complete re-build required. Breast walls were burst and pile to cap connection was lost.

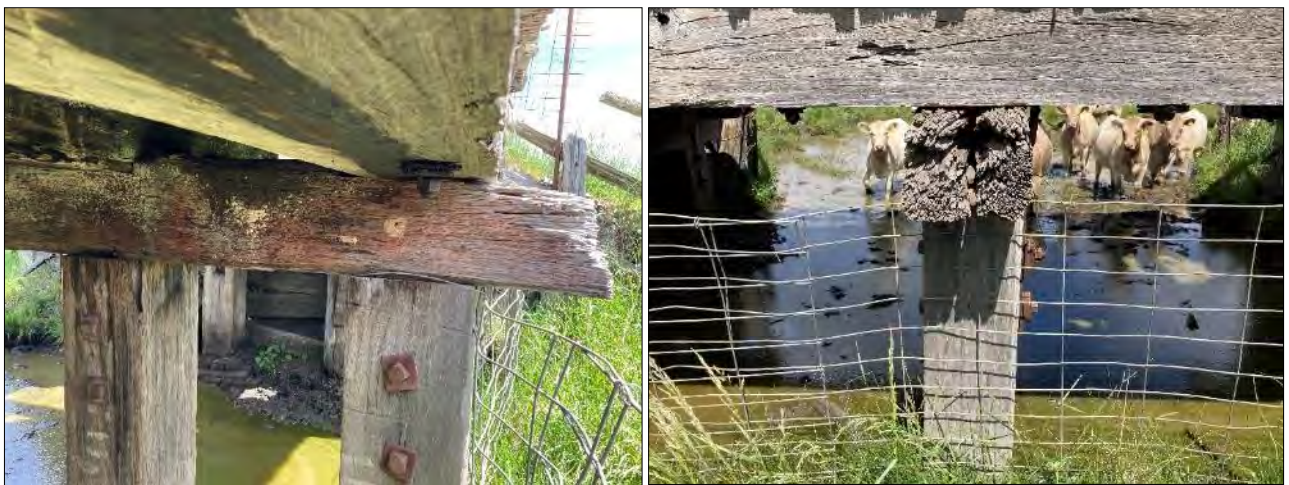
**Figure 4-3:** Most elements have started to undergo significant decay with Bent 1 cap visibly decayed above. Large amounts of fungi growth (white spots) are evident on most elements and is seen in the left-hand image above. Once the moisture content in the timber elements reaches 22%, decay causing fungi are activated and the decay process begins.

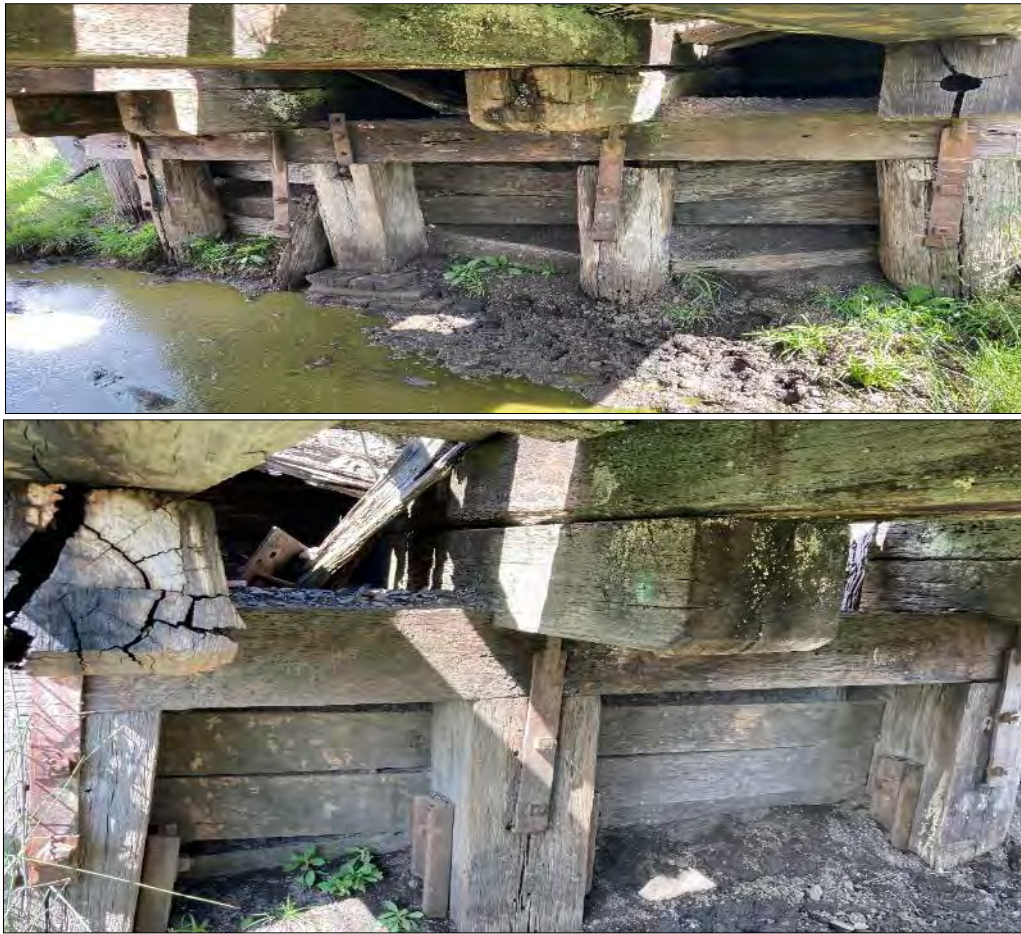
**Figure 4-4: More evidence of decay present as there is large fungi growth on most elements. Brief NDT testing was completed using non-destructive methods, such as EPHOD® Stress Wave Technology. Refer to Appendix A for more information of this type of testing method. Readings above 2000-3000 $\mu$ s was recorded for the time taken for the compression wave to travel across the section of the member tested. This was recorded on most elements. Deterioration of this magnitude means that the Modulus of Elasticity/Modulus of Rupture in various stress directions (wood is anisotropic with different strength properties in different directions) has deteriorated to an extent that the element can no longer support its own dead weight. Readings between 1000 $\mu$ s and 2200 $\mu$ s indicate that the member cannot carry its own dead weight in these regions. Readings in excess of 2200 $\mu$ s can signify a cavity while a reading above 3300 $\mu$ s indicates the element can no longer support its own dead load and is at risk of failing at any point. Refer to Section 4.3 below for a full list of recommended repair options for refurbishment to a pedestrian/cycle bridge.**

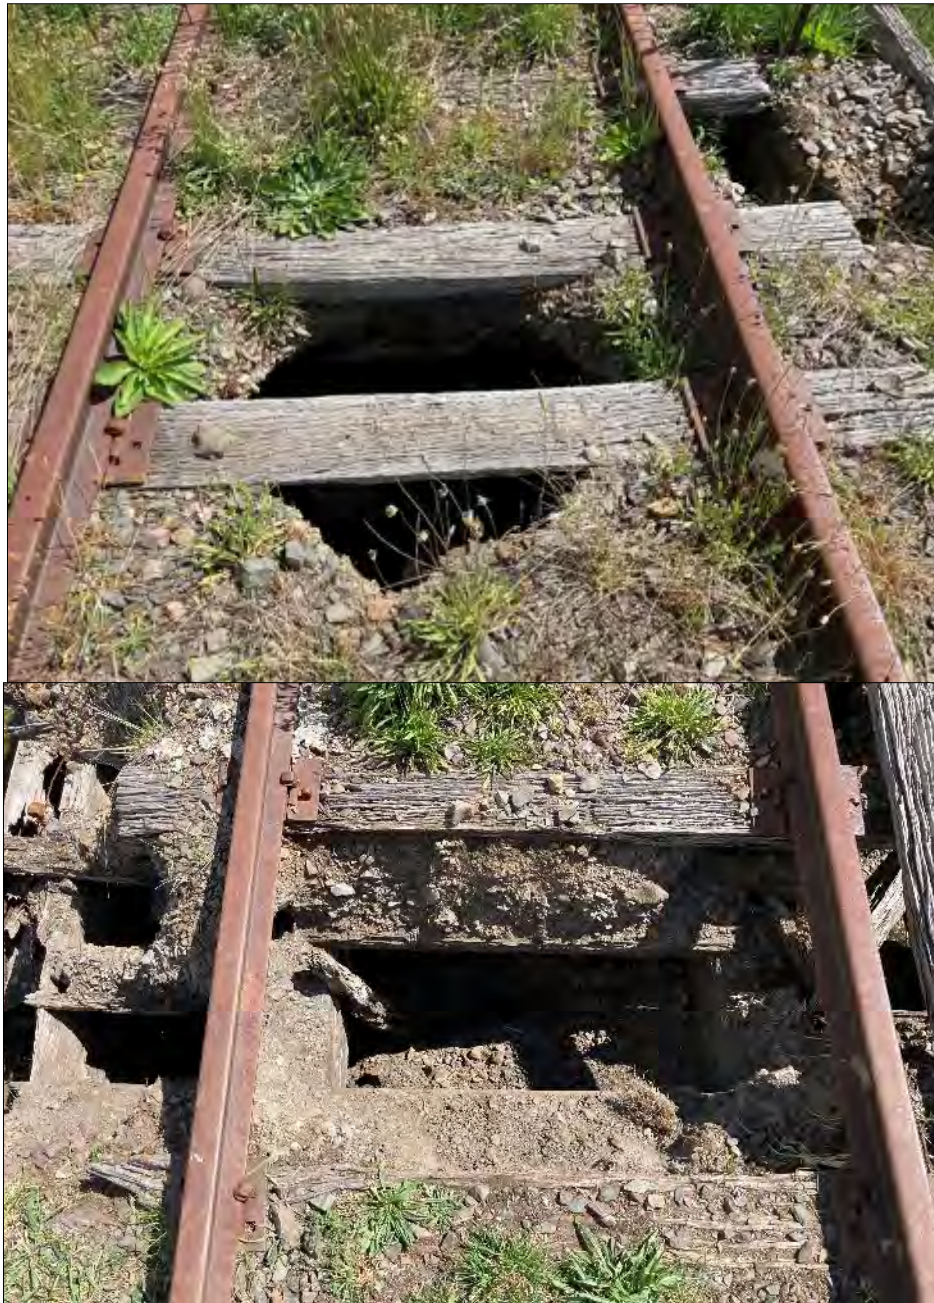
**Figure 4-5:** The timber transoms (rail ties) were found to be in a poor condition with fouled ballast and lost ballast. If the bridge was to be repurposed for pedestrian and cycle use the timber transoms, railway line and rock ballast would be required to be removed. The existing timber edge rail that contains the ballast can left in place to act as a kerb/kick rail in the repurposed bridge. To meet the current standards and Australian codes; vertical balustrade panels and a 1.4m high cycle rail will need to be installed. The current width of the bridge from inside of kerb to inside of kerb is approximately 3.0 metres which will result in a code compliant width for pedestrian bridges. As many of the deck planks are ‘falling’ out a new deck would be required for this bridge.

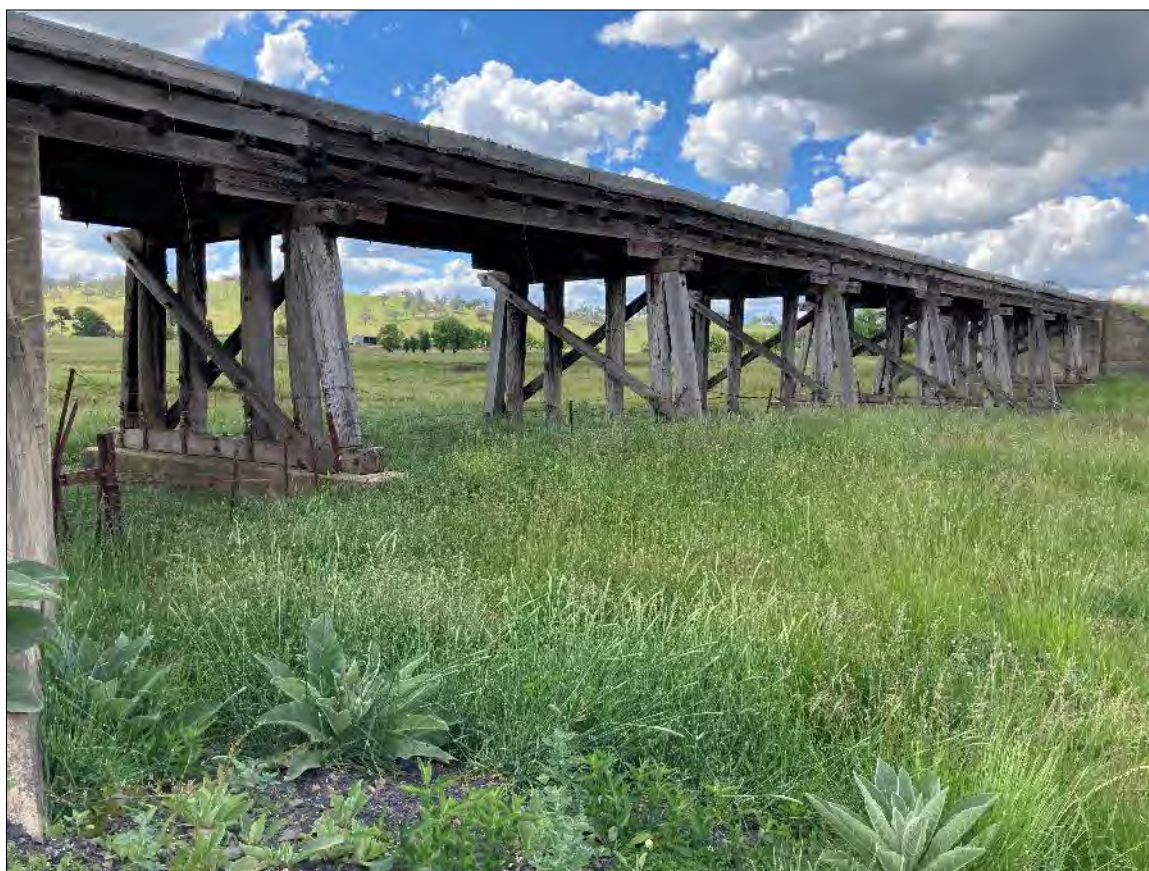
**Figure 5-1: View of Manrowan Creek Bridge from the Abutment 1 end of the structure. The timber girder under bridge has 8 spans in total with an overall length of 56m. This type of design was quite common for the longer spans that transverse over the larger creeks along the New England Railway line. At the time of inspection there no water flowing in Manrowan Creek, only a pool of water approximately 1m deep at spans 5 & 6.**

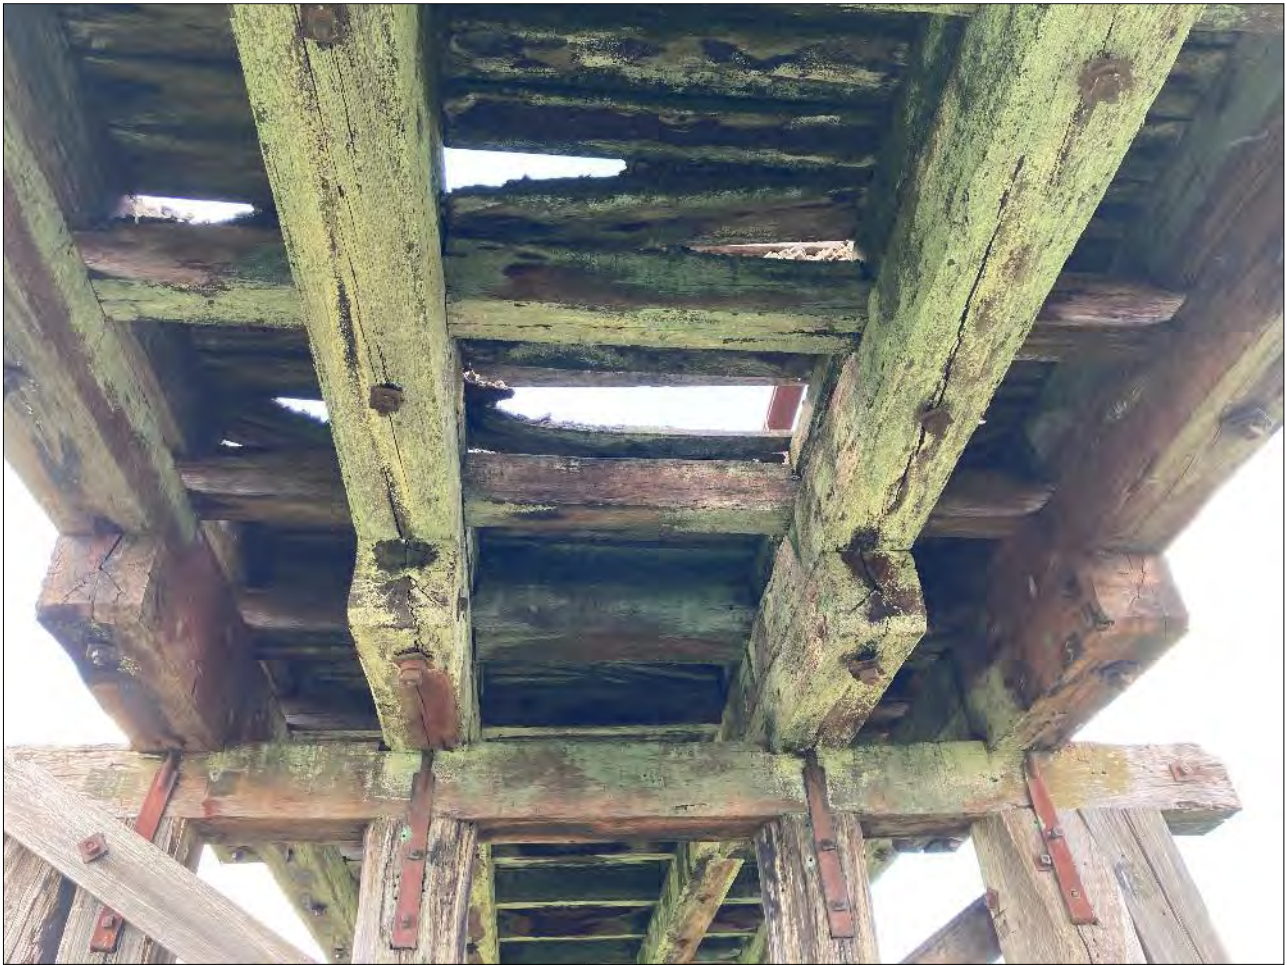
**Figure 5-2:** A view of the underneath section of the bridge. It can be seen that the deck has collapsed in sections along the bridge. These planks will require replacement before the bridge can be reopened for pedestrian and cycle use. The superstructure comprises of 4 solid sawn girder lines per span with the 2 girders per a girder line (8 girders per span in total). The double stacked girders are separated by traverse beams that contribute to the load sharing ability of the superstructure. Generally the transverse beams were in poor condition and the girders are in poor-very poor condition. One of the girders has undergone significant deterioration with large splits visible from the underneath as well as being covered fully in decay fungi growth. The girders and corbels are connected with large vertical through bolts. Vertical fasteners increase the rate of decay in timber as they allow moisture to travel down the fastener into the heartwood of the girders and corbels where evaporation is more difficult, therefore increasing the moisture content in the middle of these elements over longer periods of time. The heartwood of a large dimensional element is less capable of breathing and expelling moisture than the sapwood that surrounds it, so vertical connectors funnel the moisture directly into the heartwood accelerating decay. Once the moisture content exceeds 22%, timber consuming fungi are activated and the decay process begins. Refer to Figure 3-2 for a detailed description of how and where the decay occurs due to these vertical bolts.

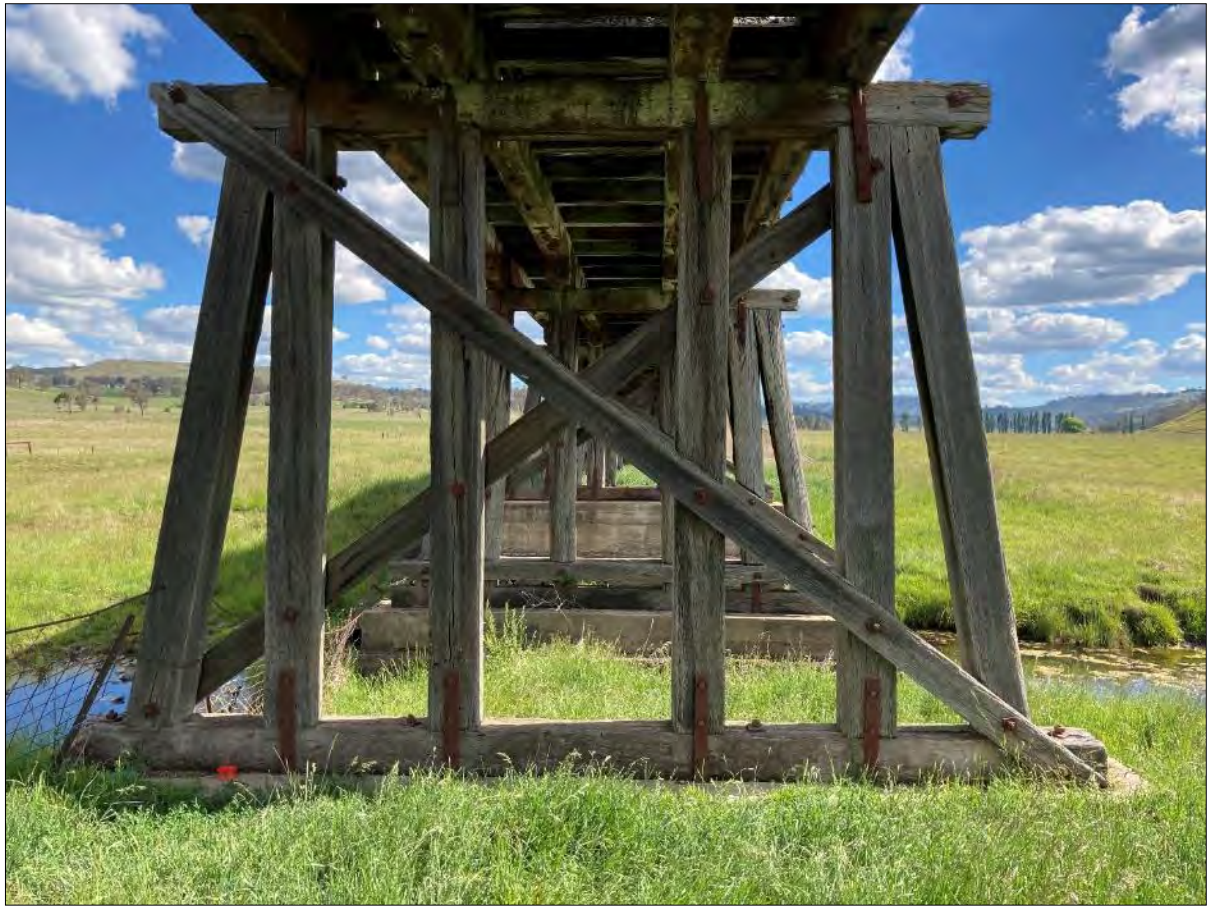
**Figure 5-3: View of the typical timber pile bent configuration. The bent comprises of 6 square (or round) dimensional post bearing directly on a timber bottom cap which is vertically connected to the concrete footing. The bent is also supported by cross bracing that provides adequate support for the 2.5-4m long posts. Overall the timber bents were found to be in a poor condition with the timber bottom caps being in the worst condition. This is as per expected due to the timber bearing directly on the concrete footing which typically has a high moisture content. Over time the timber post undergoes capillary action and draws up the moisture like a ‘straw’. Once the moisture content in the timber elements reaches 22%, decay causing fungi are activated and the decay process begins. This timber bottom cap has partially ‘protected’ the timber posts which are in relatively poor condition, however the timber cap wales will cost a significant amount to be replaced or repaired in-situ.**

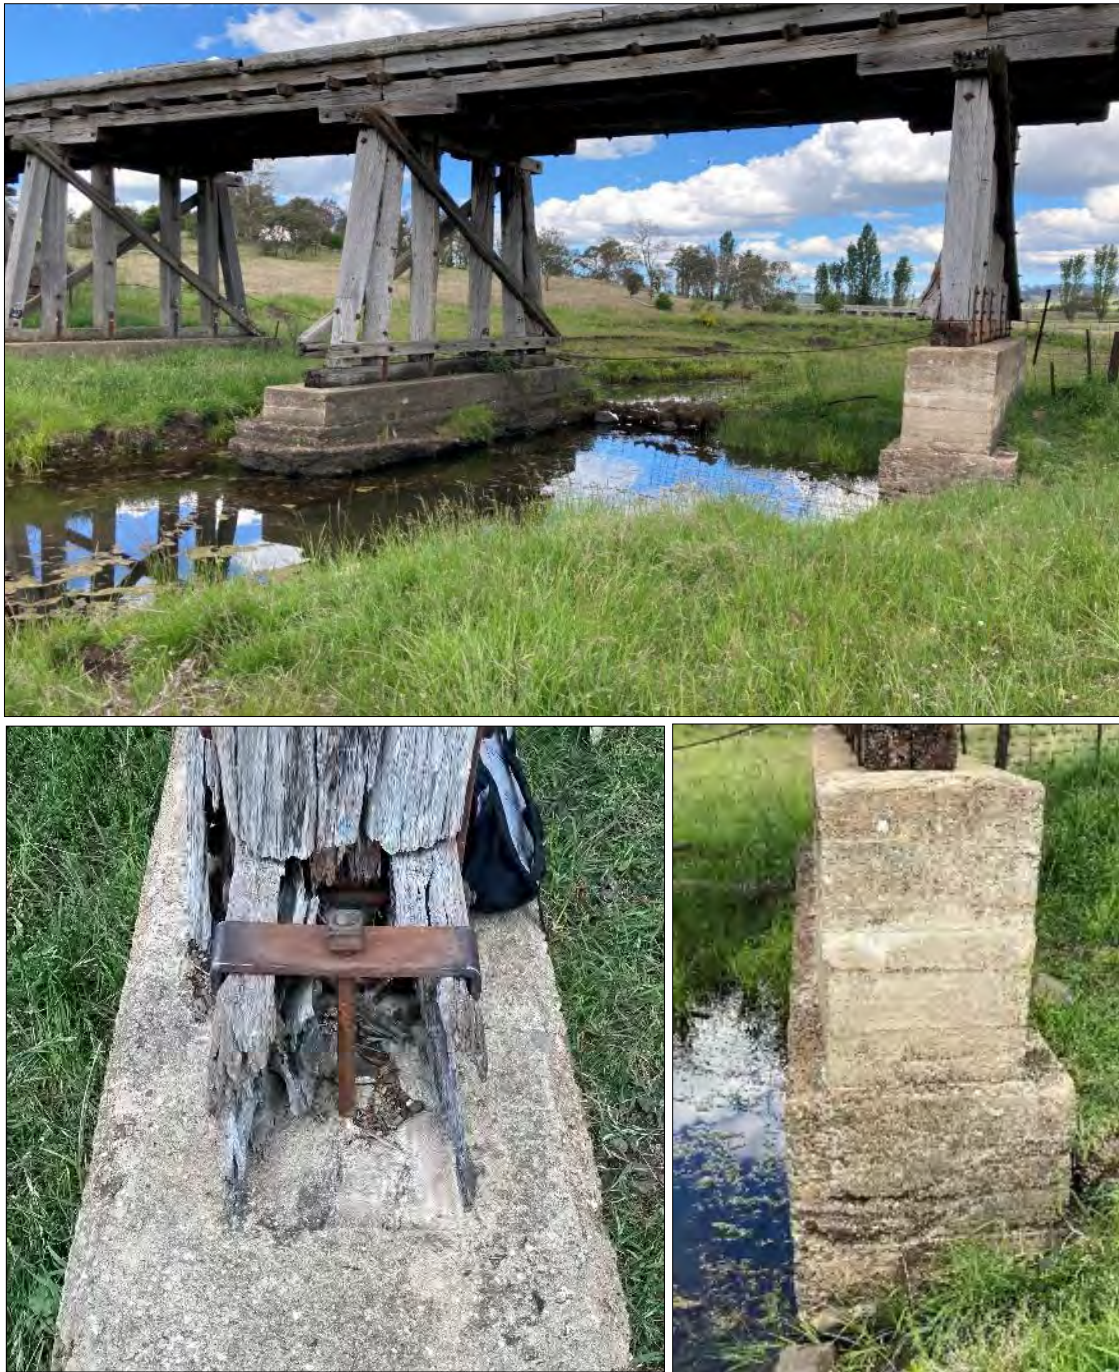
**Figure 5-4:** View of Spans 5 & 6 where the creek mainly flows. A close-up view of the decayed bottom cap that is vertically connected to and directly bearing on the concrete footing. Also the 2 concrete footing on either side of the main stream flow (Span 5) have signs of deterioration and scour. Scour protection (rip rap) is recommended to be installed.

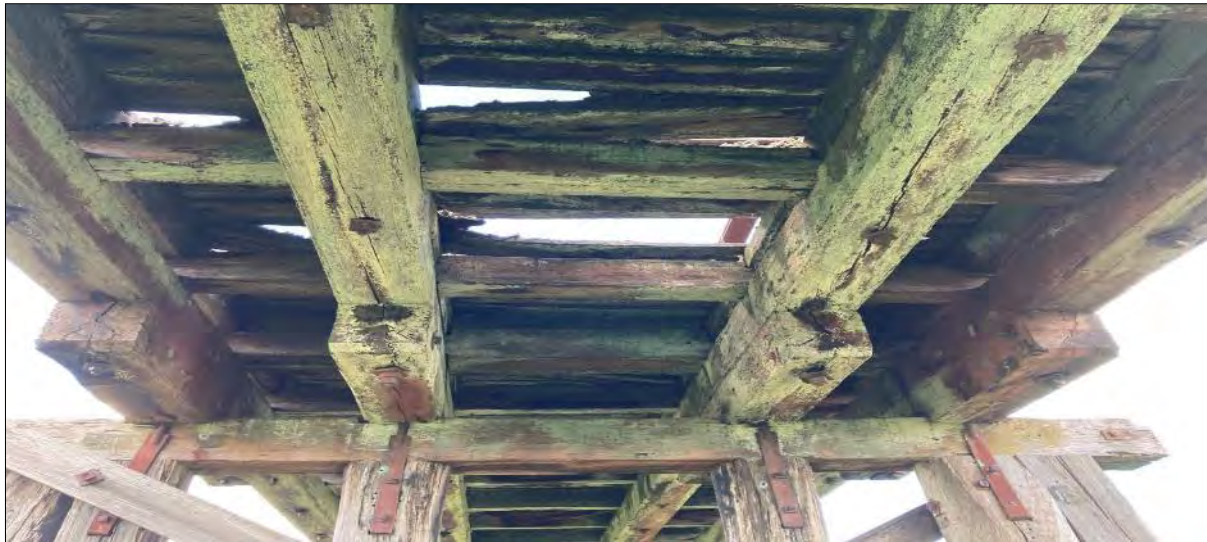
**Figure 5-5:** A view of a section of the deck that has collapsed. These planks will require replacement before the bridge can be reopened for pedestrian and cycle use. The ballast rock will also be required to be removed to accommodate pedestrian and cycle traffic. Large amounts of decay fungi growth evident which indicates large amount of deterioration present.

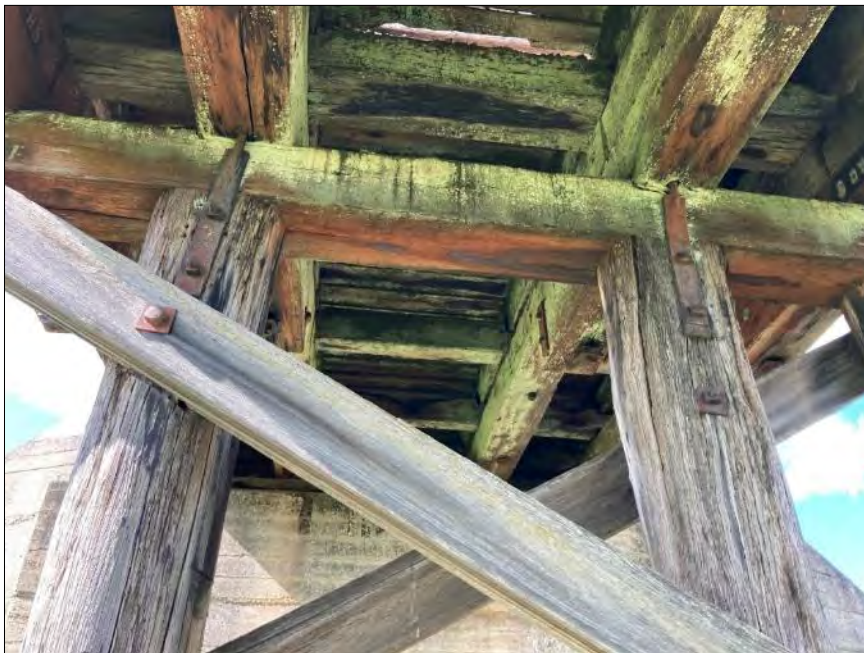
**Figure 5-6:** Close-up view of the approach span. The members are connected with a vertical through bolt. Vertical fasteners increase the rate of decay in timber as they allow moisture to travel down the fastener into the heartwood of the girders and corbels where evaporation is more difficult, therefore increasing the moisture content in the middle of these elements over longer periods of time. The heartwood of a large dimensional element is less capable of breathing and expelling moisture than the sapwood that surrounds it, so vertical connectors funnel the moisture directly into the heartwood accelerating decay. Once the moisture content exceeds 22%, timber consuming fungi are activated and the decay process begins.

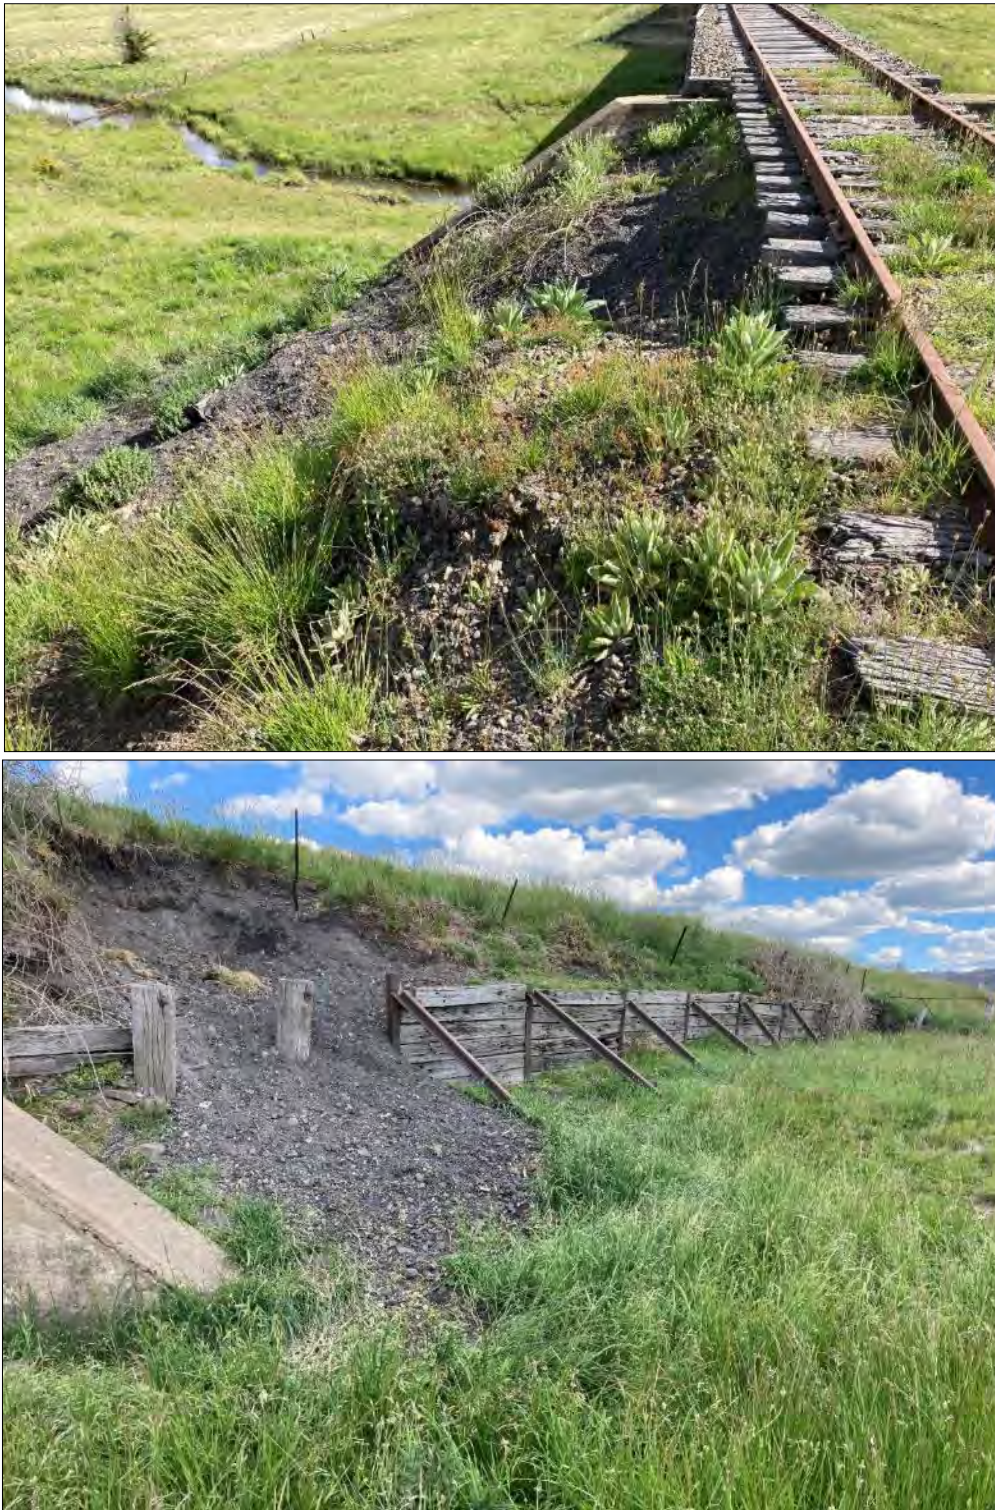
**Figure 5-7: View of the typical approach configuration. The formation of the line has been significantly raised to pass over the creek which has resulted in steep unstable slopes on each side/end. The approach retaining wall is in very poor condition and requires repair to achieve a safe and stable approach formation.**

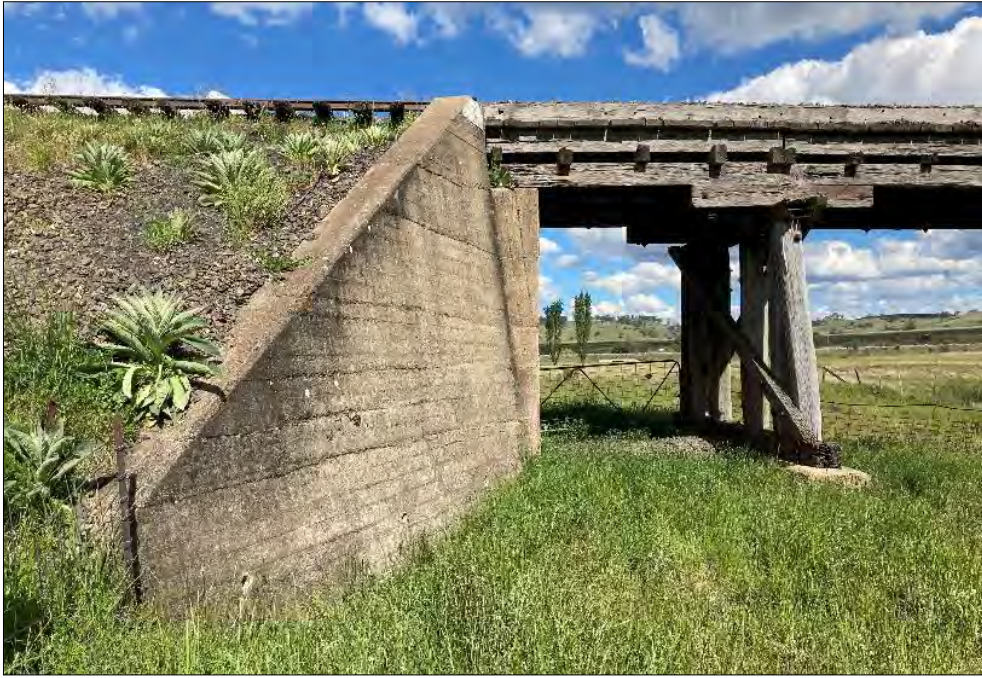
**Figure 5-8: View of Abutment 1 which is the typical board-formed, poured place, concrete wing and breast wall configuration. The concrete mass block/seat is in fair condition with the wingwalls intentionally angled back towards the approaches to help overcome the large forces from the approach fill.**

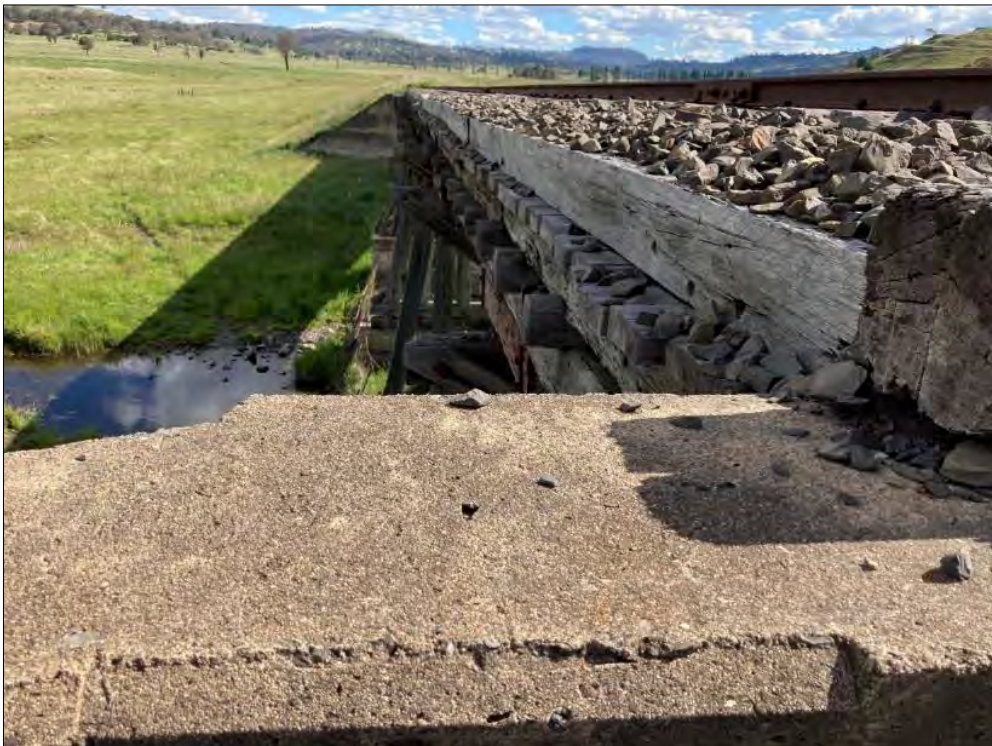
**Figure 5-9: View of Side 2 (Right-hand side) of the bridge from Abutment 2. The bridge maintains a fairly straight alignment while the decay of the bents/girders are visible to the uneven ‘drops’ along the length of the bridge. The ballast tray remains intact with most of the ballast.**

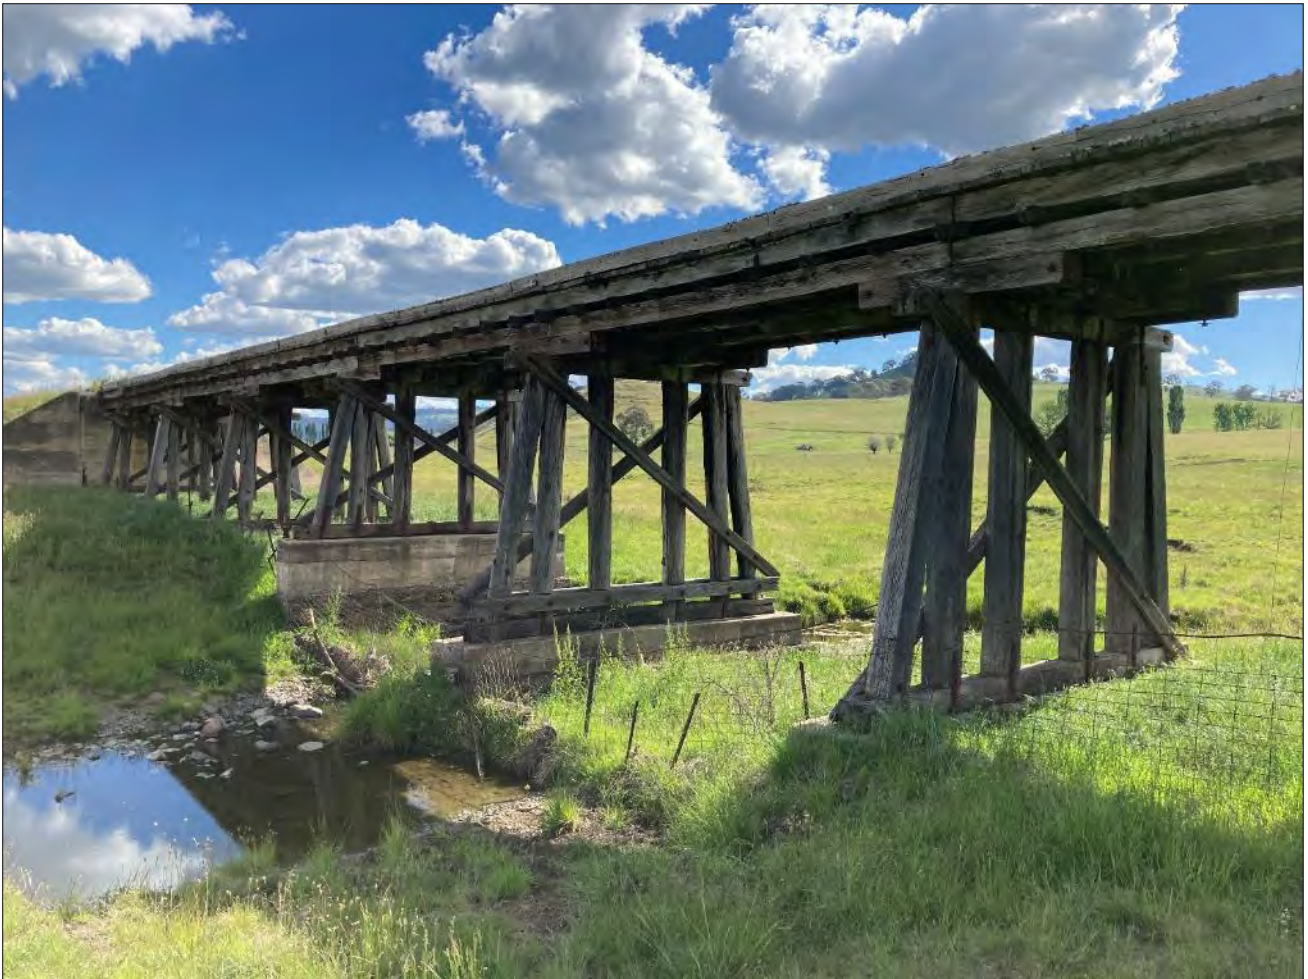
**Figure 5-10: View of Manrowan Creek from Abutment 2 side of the creek. Note the fence attached to the bridge which can have a negative impact on the bridge due to the increased chance of debris getting trapped and thus the lateral loads on the bridge increase.**

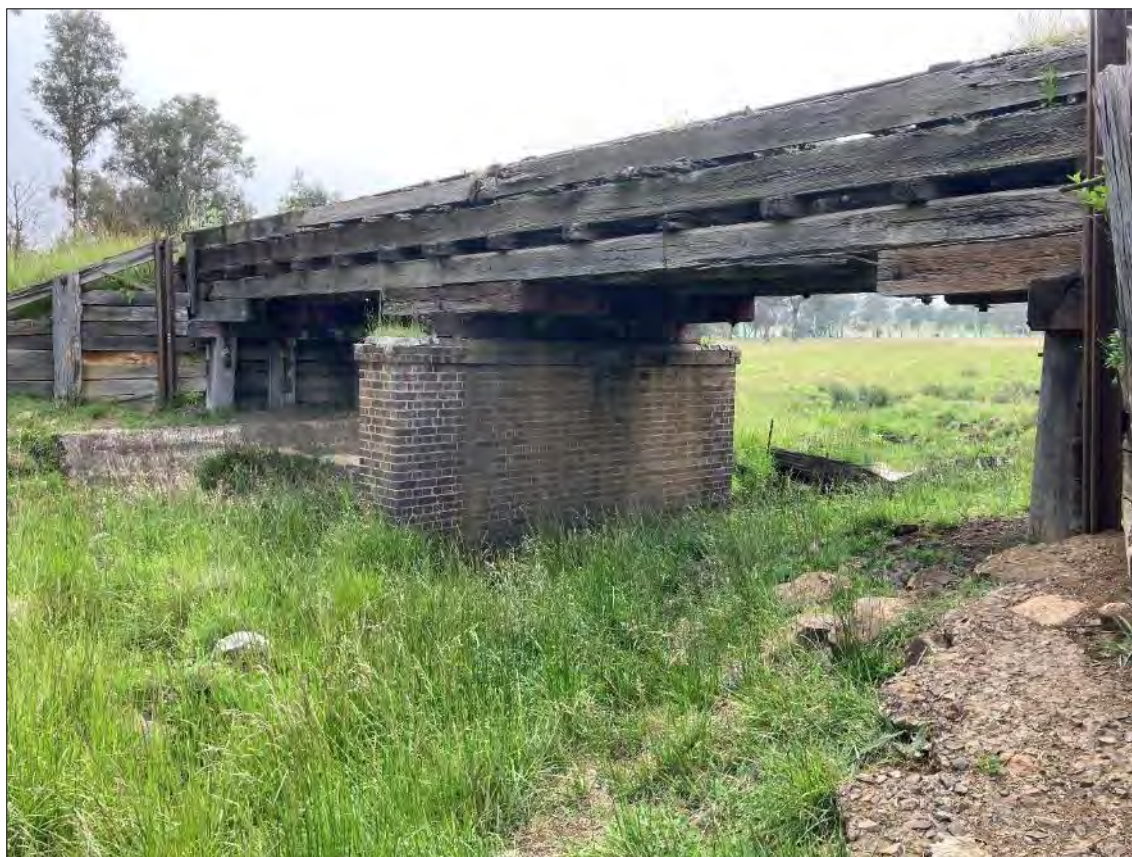
**Figure 6-1: View of Upper Williams Creek Bridge from Abutment 1 end of the bridge. Abutment 1 (Southern end) is to the right side of the image above. The natural flow of the creek is through span 2 with no water flow at the time of inspection. The configuration and current condition of the bridge is similar to Manrowan Creek Bridge with a beautiful brick pier (which can be saved to protect the construction of the era) instead of timber bents. The timber bridge is only 2 spans long and approximately 14 metres in length.**
