# New England Rail Trail

## Trail Development Plans

Armidale – Black Mountain  
Ben Lomond – Glen Innes

## DRAFT REPORT

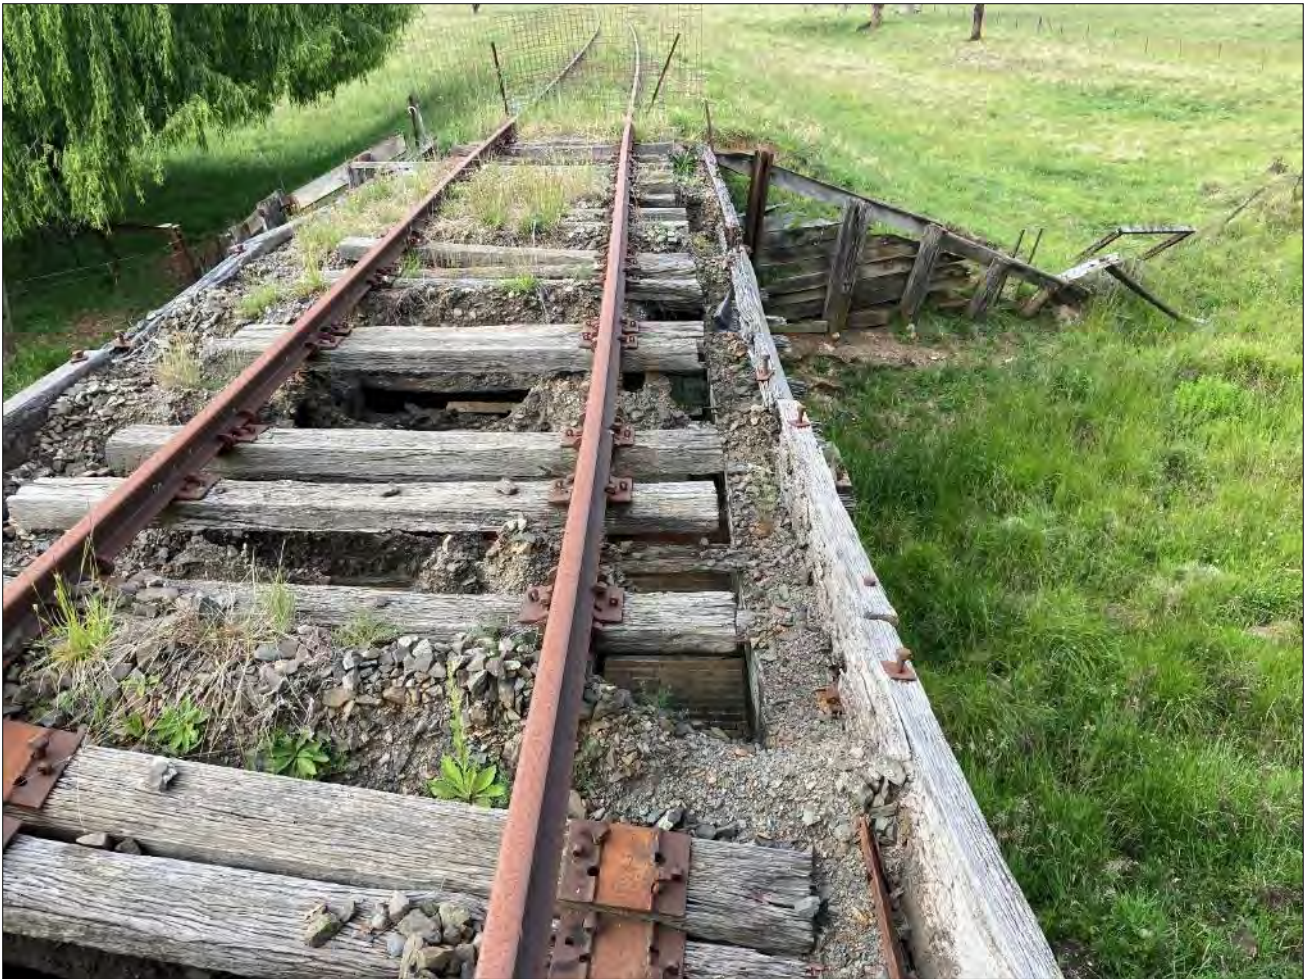
**Figure 6-2:** The deck planks that support the ballast rock are in very poor condition with many of the planks missing and large amounts of ballast have fallen out.

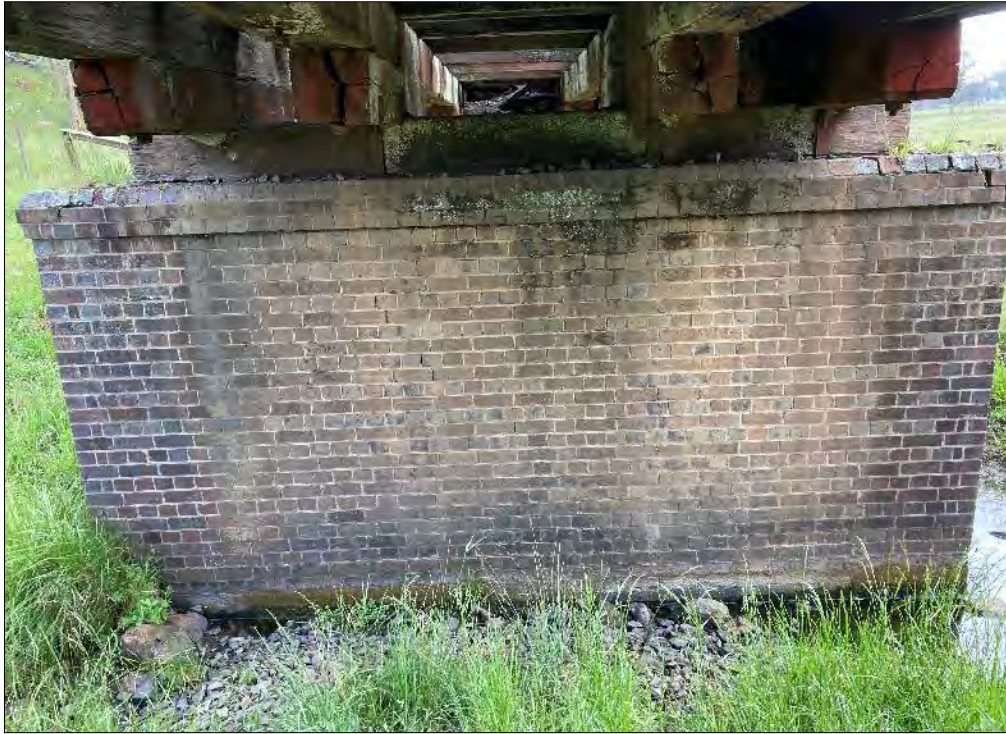
**Figure 6-3:** View of the brick pier that is approximately 3 metres in height. The timber girders are supported by corbels that rest on a timber cap that bears directly on the brick pier. On either side of the pier there are signs of deterioration and scour. Scour protection (rip rap) is recommended to be installed.

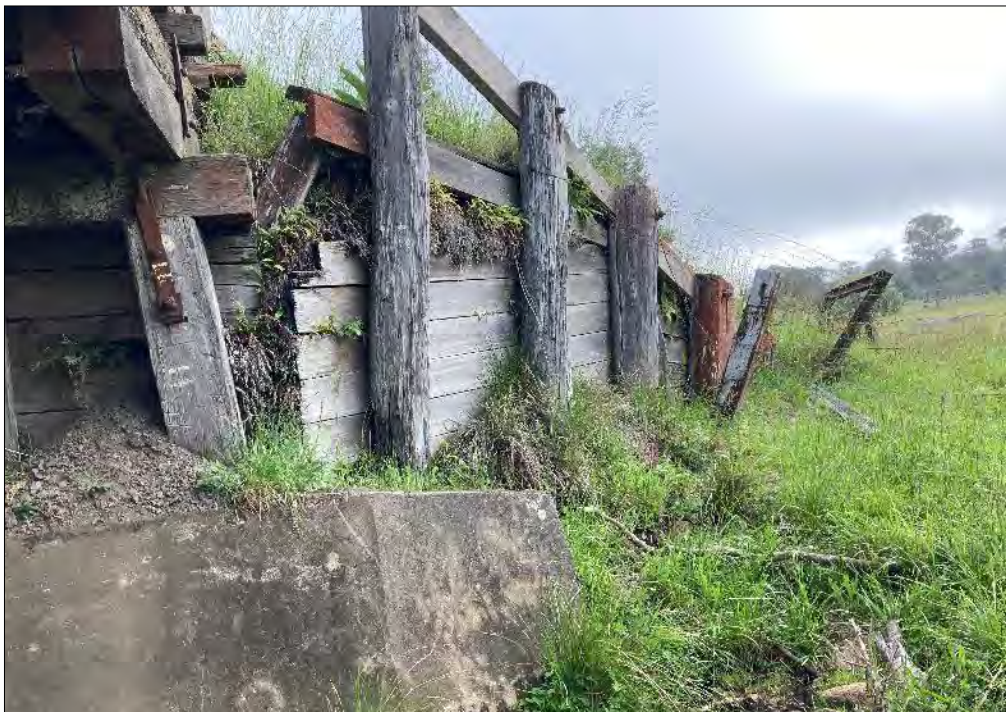
**Figure 6-4:** View of the typical abutment wingwall configuration and condition. The timber breastwall and wingwall planks have undergone significant deterioration and are now leaning 'outwards'. There is a loss of fines and larger aggregate from the approach through the breastwall.

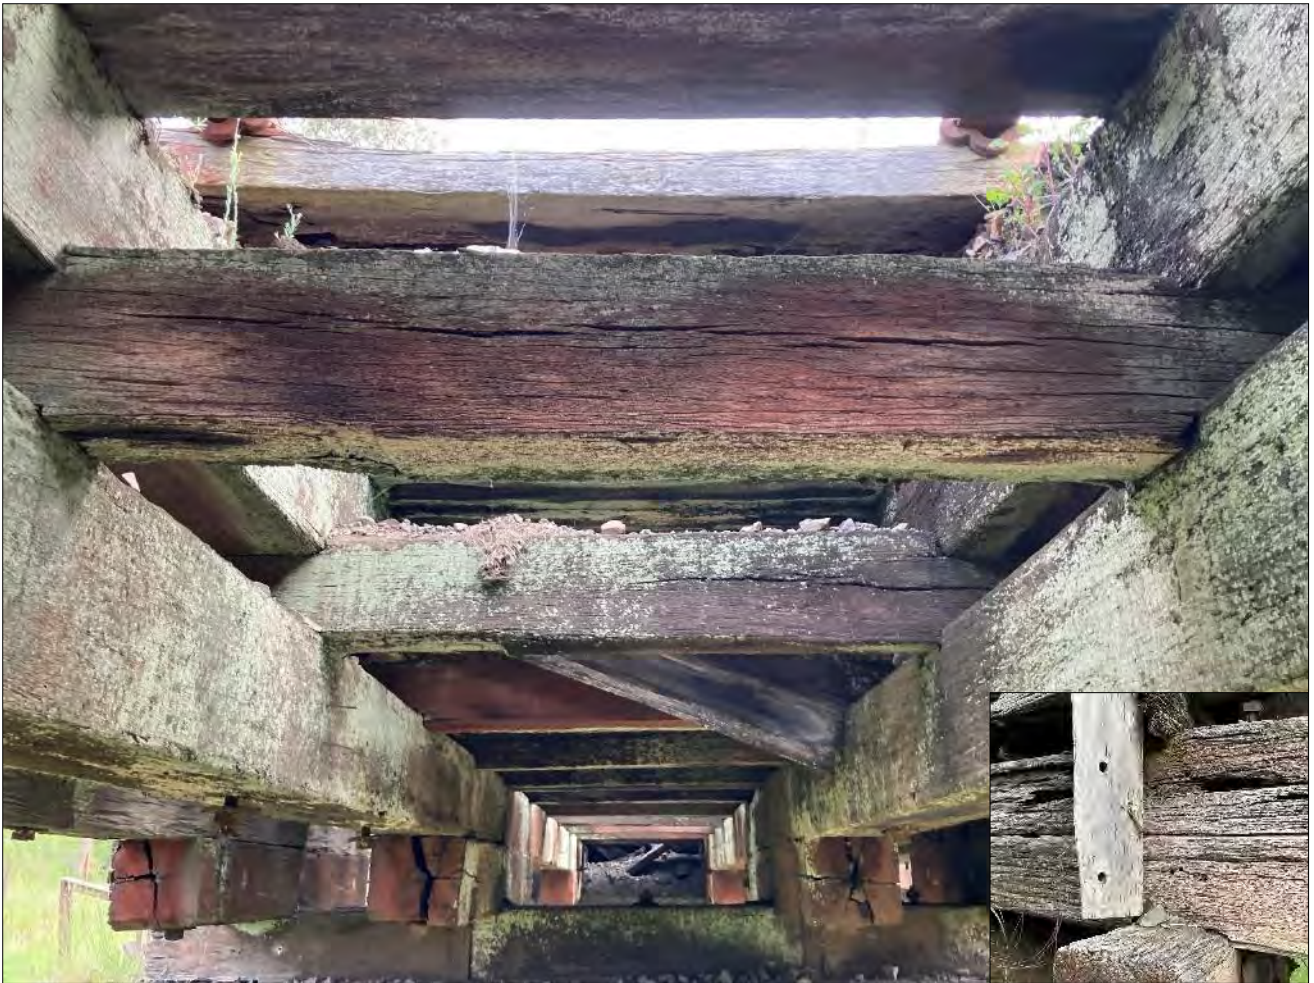
**Figure 6-5:** A view of the underneath section of the bridge. It can be seen that the deck has collapsed in sections along the bridge. These planks will require replacement before the bridge can be reopened for pedestrian and cycle use. The superstructure comprises of 4 girder lines per span with the 2 girders per a girder line (8 girders per span in total). The double stacked sawn square girders are separated by traverse beams that contribute to the load sharing ability of the superstructure. Several of the girders has undergone significant deterioration with large splits visible from the underneath. The girders and corbels are connected with large vertical through bolts. Vertical fasteners increase the rate of decay in timber as they allow moisture to travel down the fastener into the heartwood of the girders and corbels where evaporation is more difficult, therefore increasing the moisture content in the middle of these elements over longer periods of time. The heartwood of a large dimensional element is less capable of breathing and expelling moisture than the sapwood that surrounds it, so vertical connectors funnel the moisture directly into the heartwood accelerating decay. Once the moisture content exceeds 22%, timber consuming fungi are activated and the decay process begins. Refer to Figure 3-2 for a detailed description of how and where the decay occurs due to these vertical bolts.

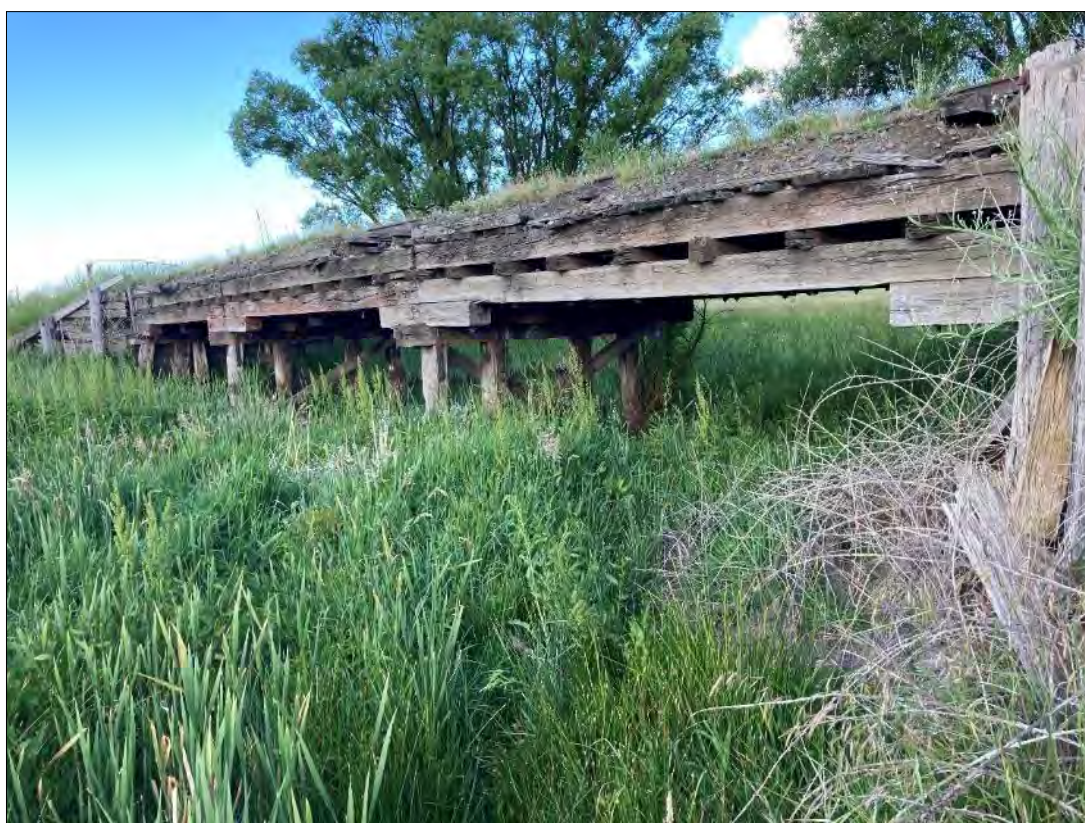
**Figure 7-1:** View of Williams Creek from Abutment 1 end of the structure. The 3 span, 24m long bridge has the same superstructure and deck configuration as Manrowan Creek Bridge with timber pile bents. There is a large amount of vegetation growth around the bridge which keeps the moisture content high in the timber. When the moisture level in the timber is above 22%, decay-causing fungi can start to grow; when the moisture content drops below this level, the fungi become dormant and decay will be arrested until the moisture content rises again.

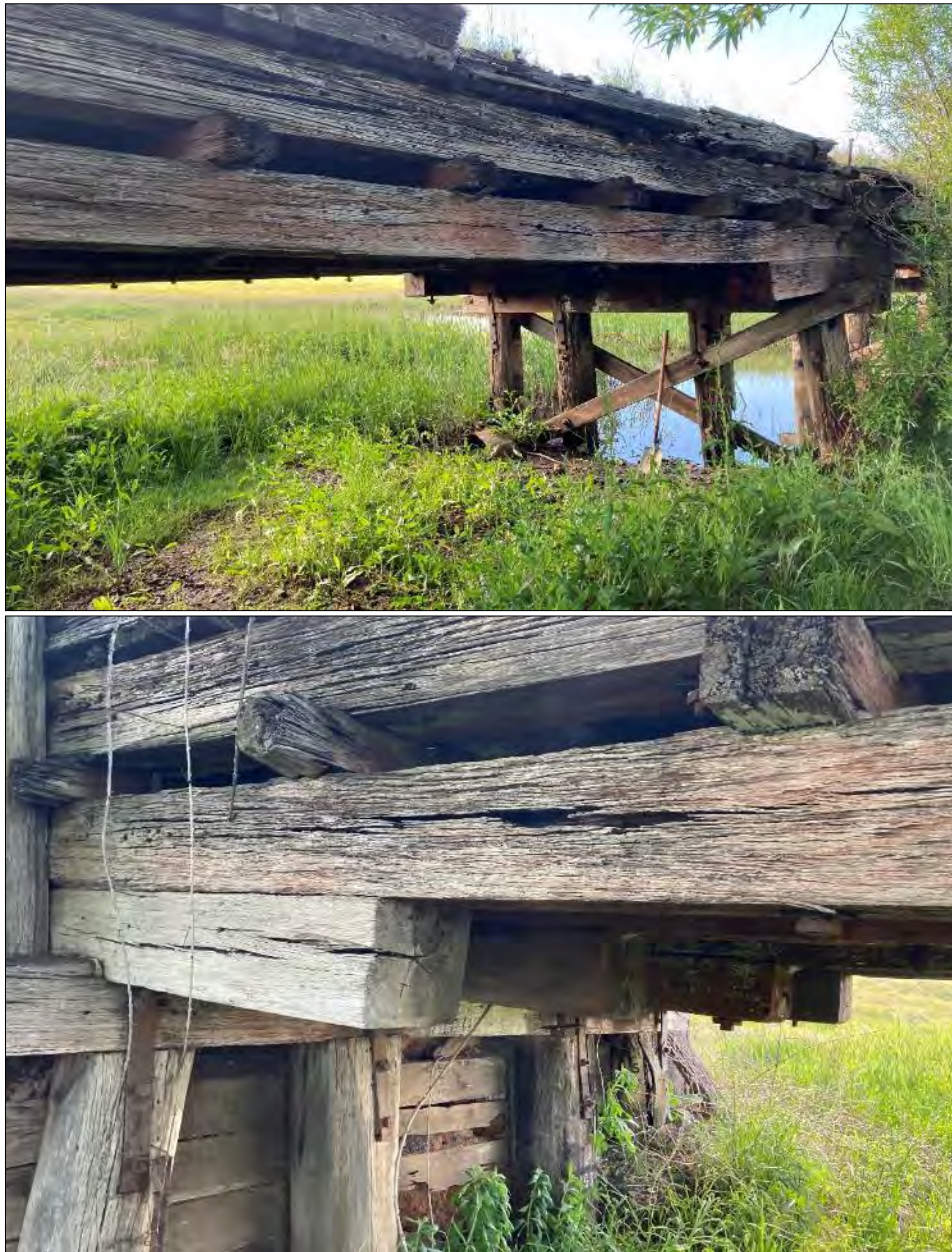
**Figure 7-2: The superstructure and deck are the same configuration and similar condition as Manrowan Creek Bridge. The girders are in very poor condition with Girder 4 in Span 1 having visible cavities and excessively deflecting under its own deadload which has result in full length cracking.**

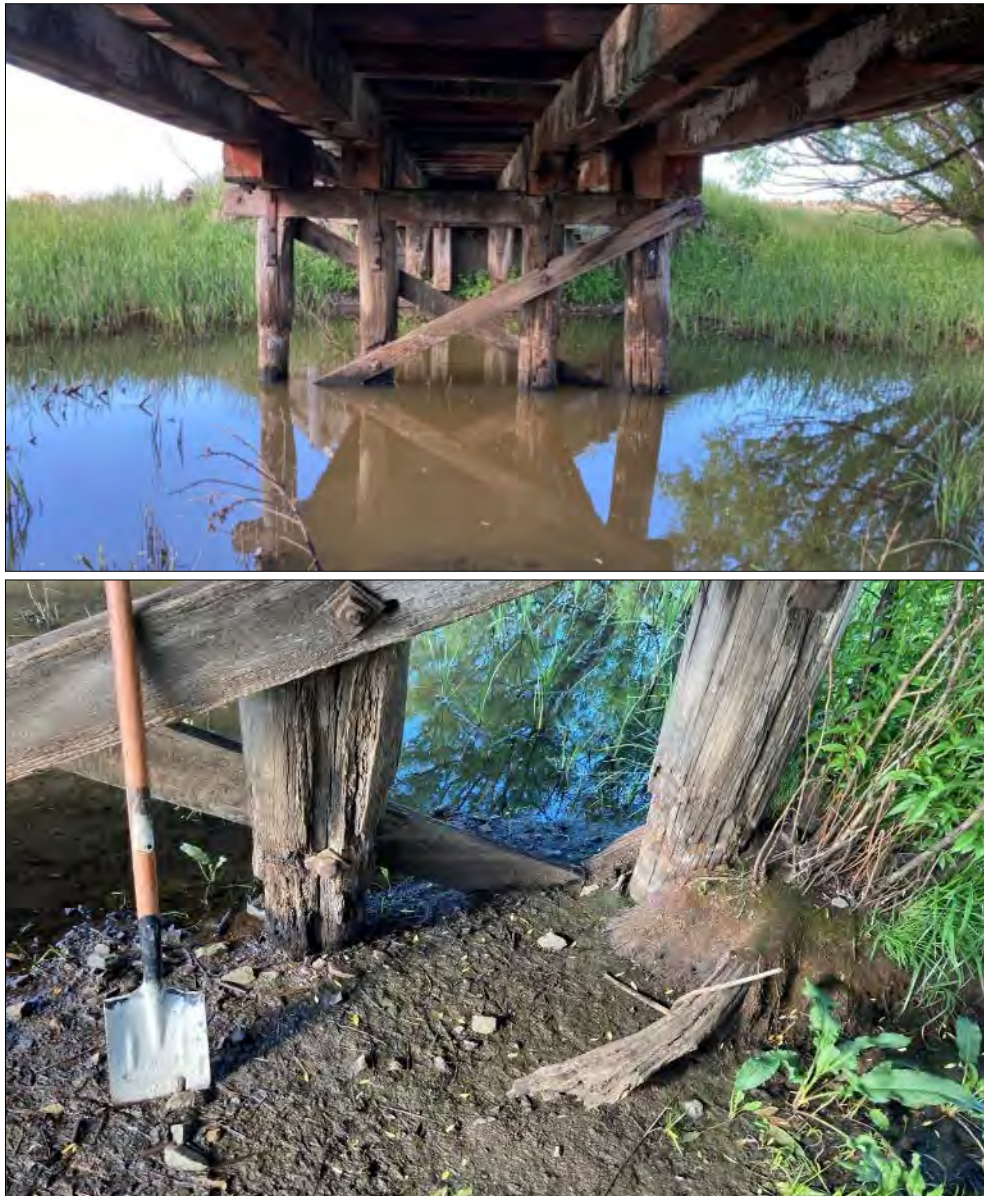
**Figure 7-3: View of Pile Bent 2 (top) and Piles 3 & 4 of Pile Bent 1. The bottom of the piles in the ‘splash’ zone are significantly deteriorated with major repairs required. These piles will also require restoration for lateral stability of the bridge. When more than 50% of the piles in the bent require replacing then it is cost effective and beneficial for longevity that the pile bent is replaced with a new frame bent. That is, all piles are trimmed down to bright (solid) wood and a new bottom cap (sill) is placed on top of the pile stubs with the new posts connected to the sill to support the new cap and corbels/girders.**

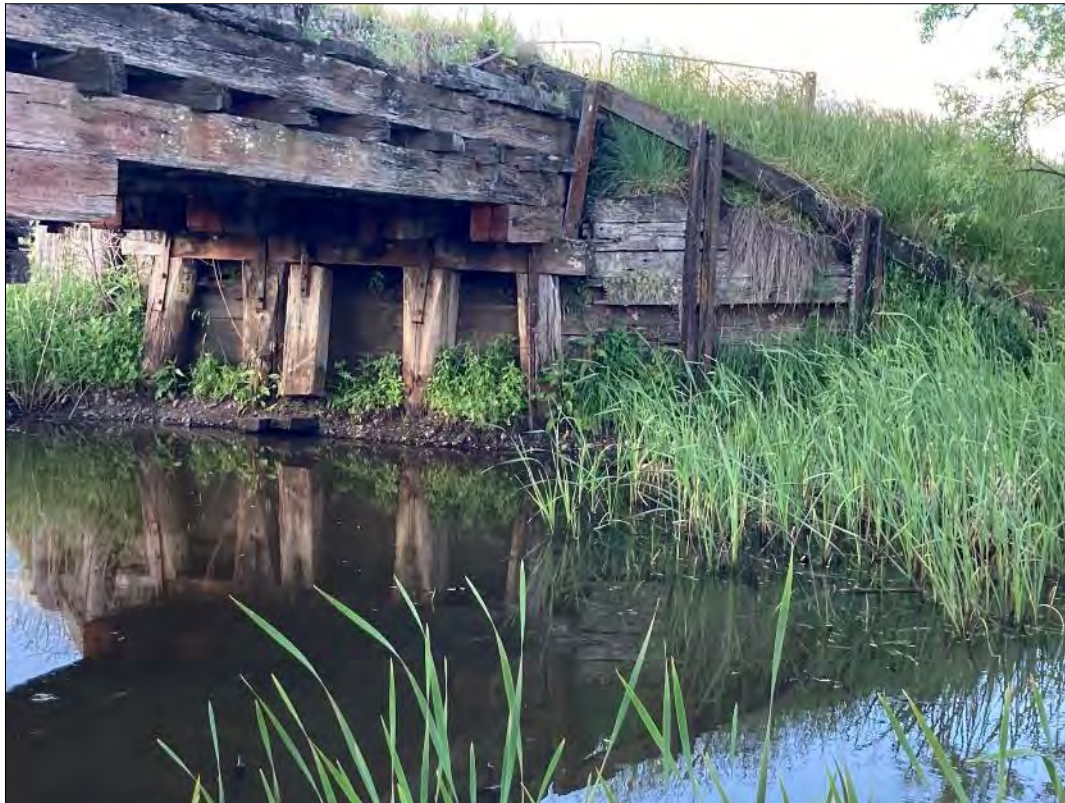
**Figure 7-4:** View of the typical abutment wingwall configuration and condition. The timber breastwall and wingwall planks have undergone significant deterioration and are now leaning ‘outwards’. There is a loss of fines and larger aggregate from the approach through the breastwall. Also note the very poor condition of the Abutment 2 piles where the central pile is ‘suspended’.

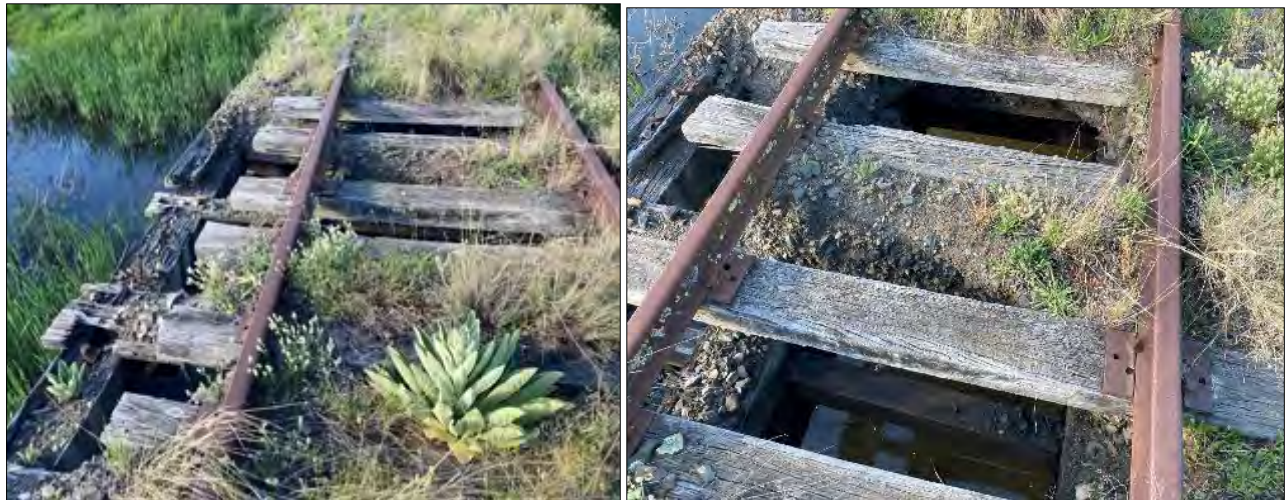
**Figure 7-5:** The deck planks that support the ballast rock are in very poor condition with many of the planks missing and large amounts of ballast have fallen out. To meet the current standards and Australian codes; vertical balustrade panels and a 1.4m high cycle rail will need to be installed along with a new deck system.

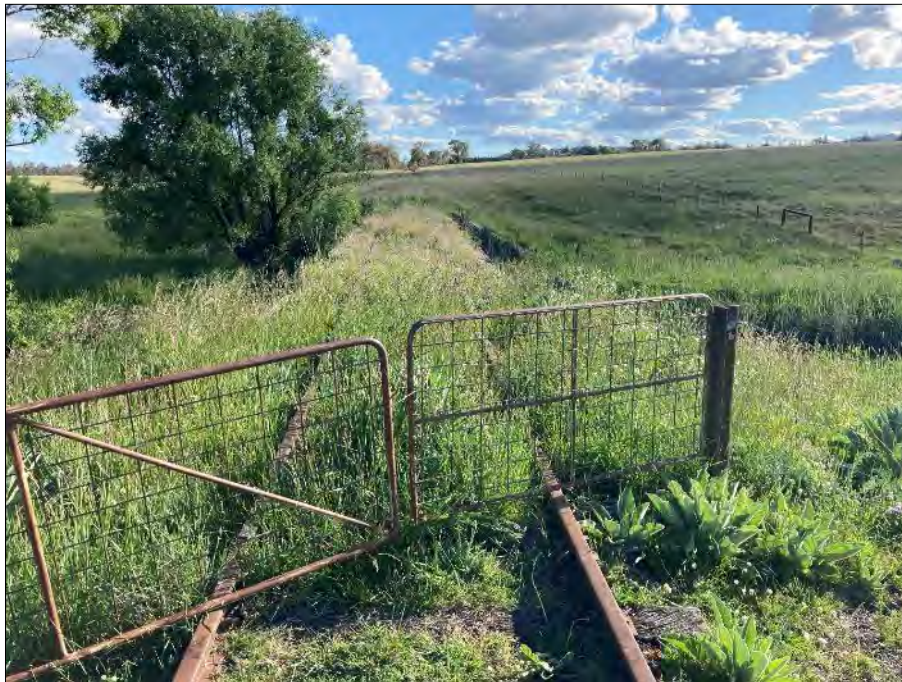
**Figure 7-7:** View from Abutment 2 end of the bridge. The vegetation overgrowth is again evident from this image as there is a large tree growing on the upstream side of the bridge.

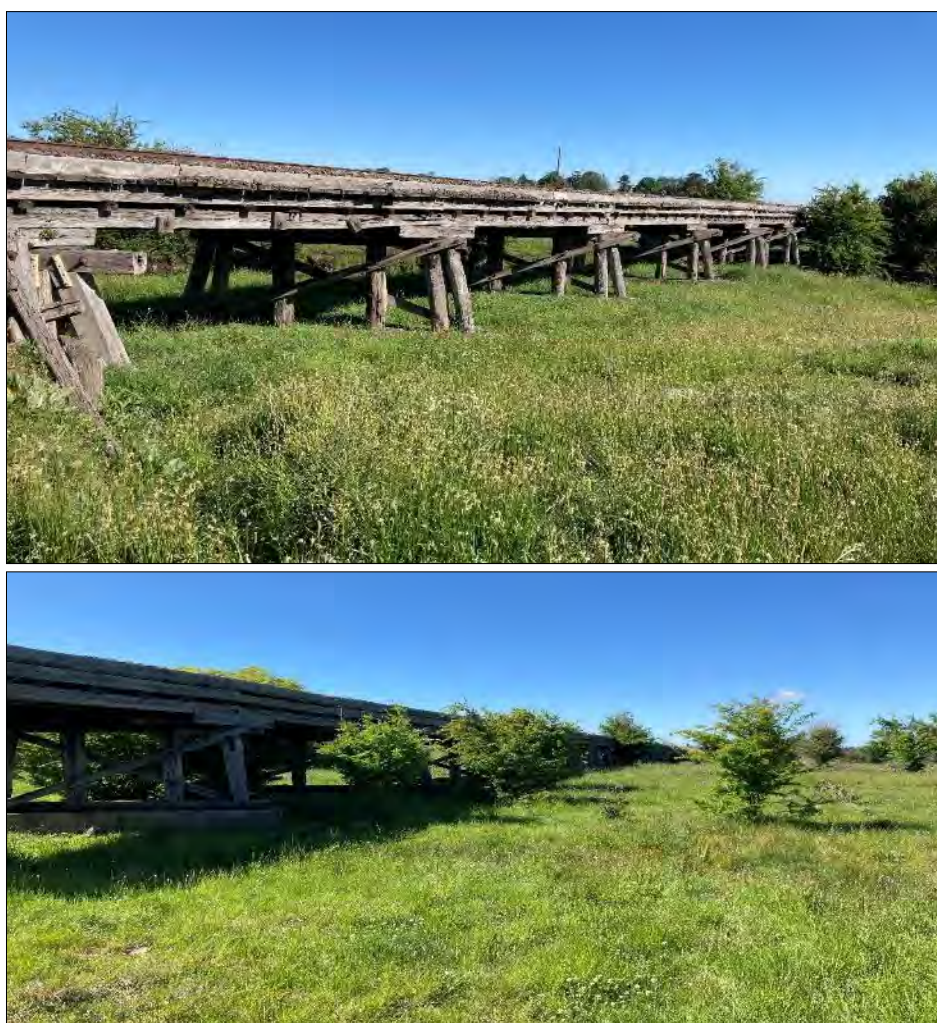
**Figure 8-1:** Top image is the view of Beardy Waters Bridge from Abutment 1 and the bottom image is from Abutment 2. The timber bridge is 14 spans long and approximately 112 metres in length (8 metre long spans). Note several of the spans at Abutment 2 side of the river are in very poor (unsafe) condition and have partially collapsed and sunken.

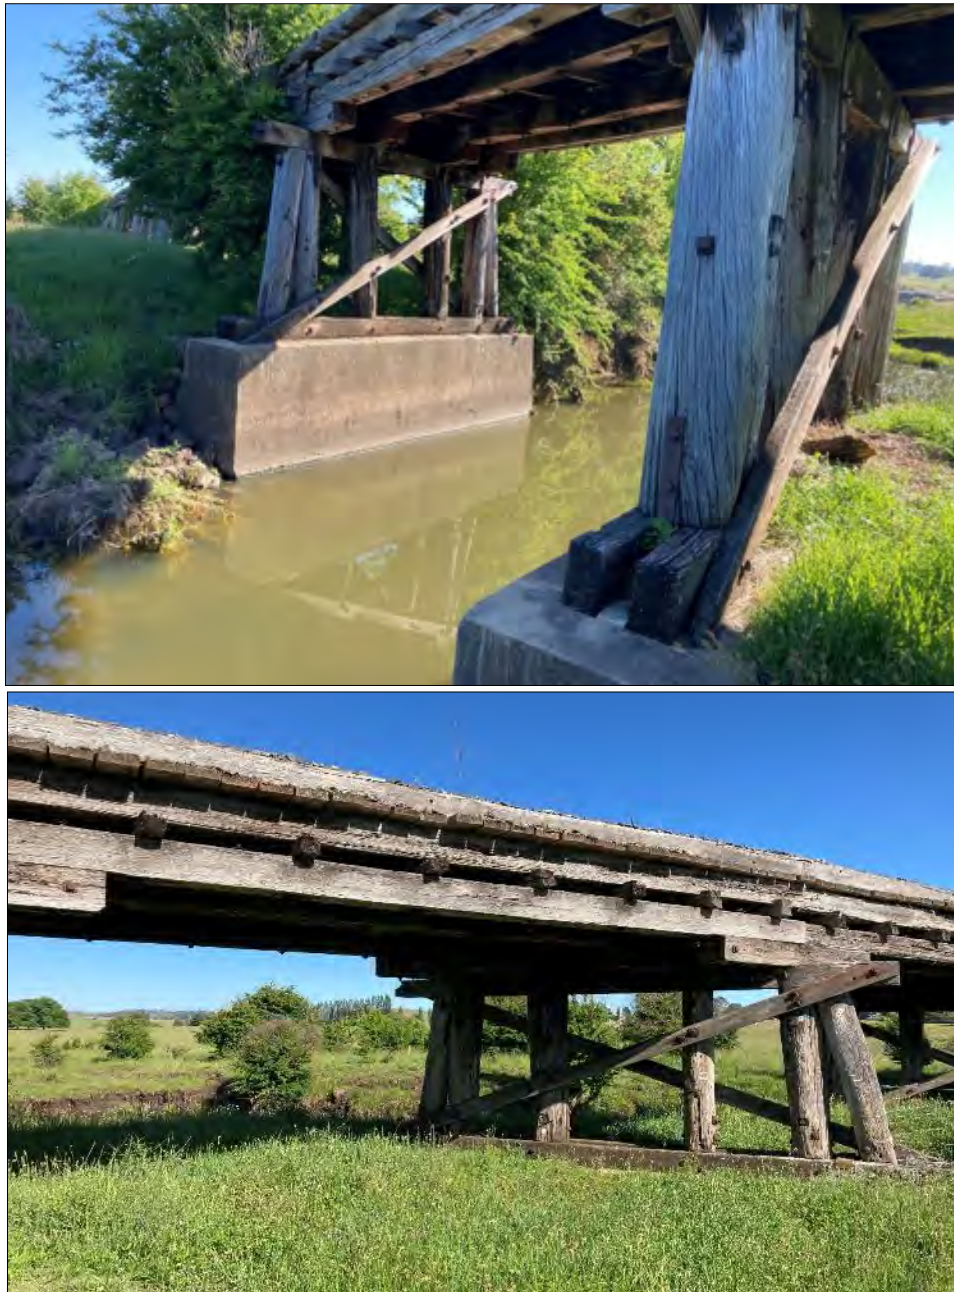
**Figure 8-2: View of the typical timber pile bent configuration. The bent comprises of 6 square (or round) dimensional post bearing directly on a timber bottom cap which is vertically connected to the concrete footing. The bent is also supported by cross bracing that provides adequately support for the 2.5-4m long posts. Overall the timber bents were found to be in a poor to very poor condition with the timber bottom caps being in the worst condition. This is as per expected due to the timber bearing directly on the concrete footing which typically has a high moisture content. Over time the timber post undergoes capillary action and draws up the moisture like a ‘straw’. Once the moisture content in the timber elements reaches 22%, decay causing fungi are activated and the decay process begins. This timber bottom cap has partially ‘protected’ the timber posts which are in relatively poor condition, however the timber cap wales will cost a significant amount to be replaced or repaired in-situ. Also note the bents are heavily skewed (approximately 30 degrees) and are parallel with the stream.**

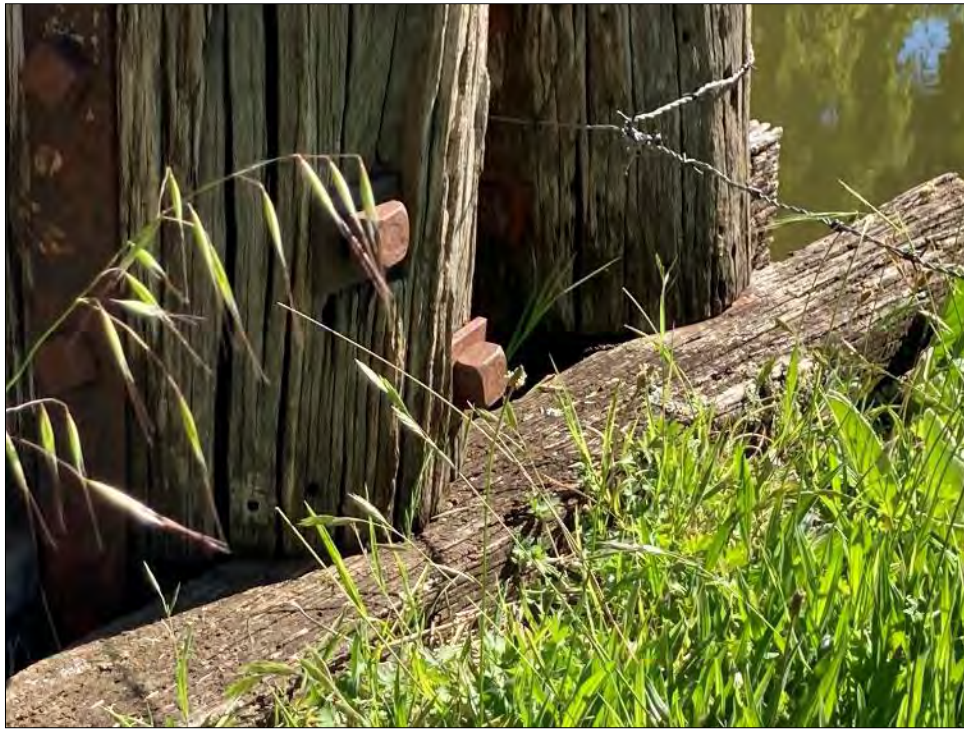
**Figure 8-3:** It was noted that the bottom section of several posts and timber cap wales have started to undergo decay. This is as expected due to the timber posts bearing directly on the concrete footing which typically has a high moisture content. Over time the timber post undergoes capillary action and draws up the moisture like a ‘straw’. Once the moisture content in the timber elements reaches 22%, decay causing fungi are activated and the decay process begins. Overall the timber bents were found to be in poor condition. The bottom sections of the timber piles were determined to be a ‘hotspot’ for decay and determined to be an ideal area to test using non-destructive methods, such as EPHOD® Stress Wave Technology. Refer to Appendix B for more information of this type of testing method. A reading of above 1500µs was recorded for the time taken for the compression wave to travel across the section of the member tested. This was recorded at the bottom of one of the piles (left image above) and was found to be similar across most of the piles/posts. Deterioration of this magnitude means that the Modulus of Elasticity/Modulus of Rupture in various stress directions (wood is anisotropic with different strength properties in different directions) has deteriorated to an extent that the element can no longer support its own dead weight. Readings between 1000µs and 2200µs indicate that the member cannot carry its own dead weight in these regions. Readings in excess of 2200µs can signify a cavity while a reading above 3300µs indicates the element can no longer support its own dead load and is at risk of failing at any point.

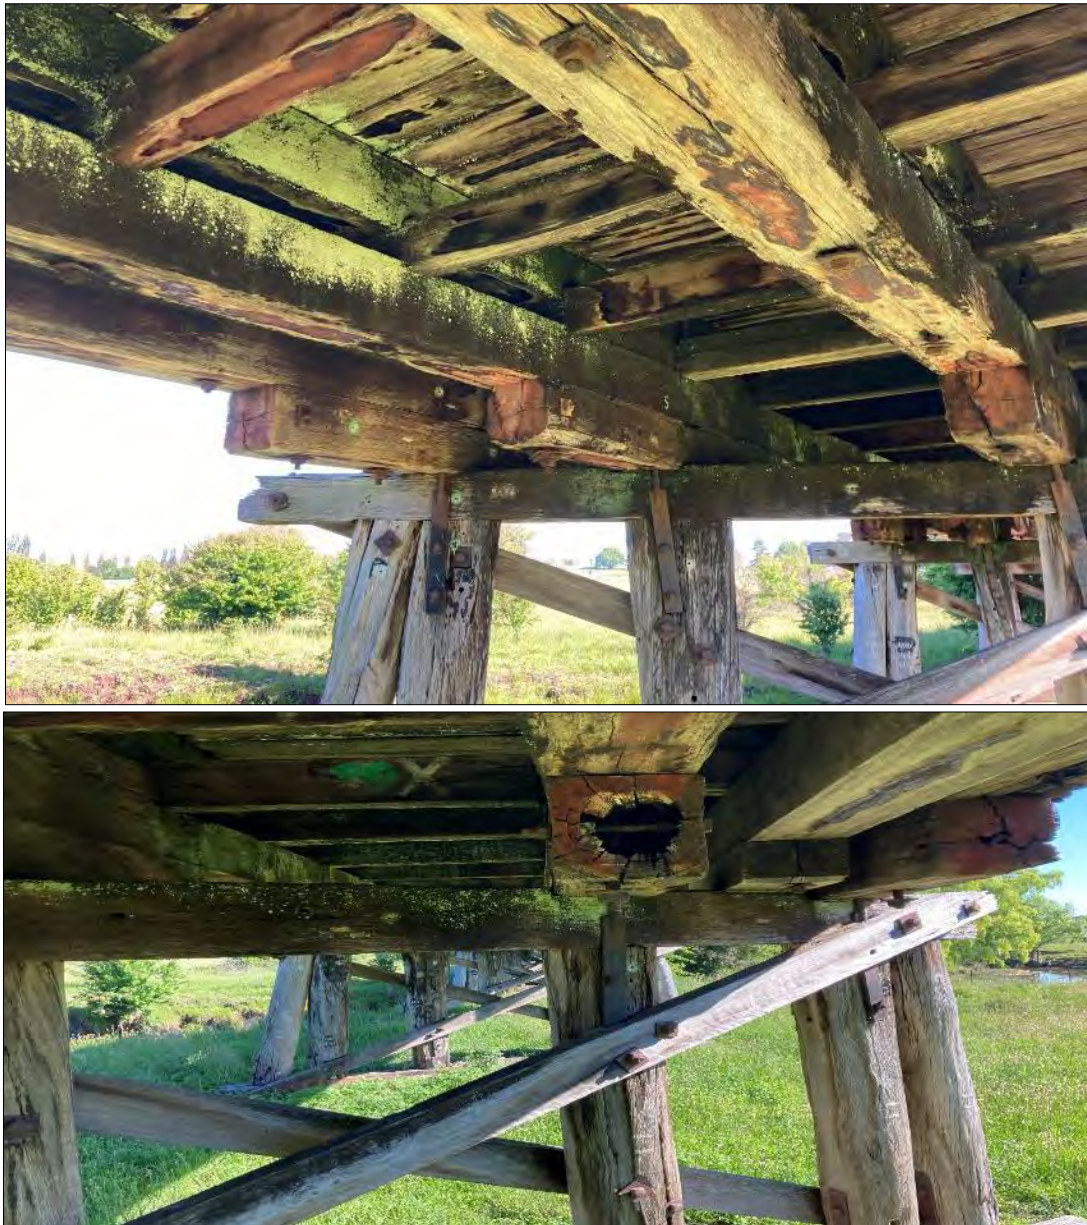
**Figure 8-4:** A view of the underneath section of the bridge. The superstructure comprises of 4 girder lines per span with the 2 girders per a girder line (8 girders per span in total). The double stacked square cut solid sawn girders are separated by traverse beams that contribute to the load sharing ability of the superstructure. Generally the transverse beams were in poor condition and the girders are in poor-very poor condition. One of the girders has undergone significant deterioration with large splits visible from the underneath as well as being covered fully in decay fungi growth. The girders and corbels are connected with large vertical through bolts. Vertical fasteners increase the rate of decay in timber as they allow moisture to travel down the fastener into the heartwood of the girders and corbels where evaporation is more difficult, therefore increasing the moisture content in the middle of these elements over longer periods of time. The heartwood of a large dimensional element is less capable of breathing and expelling moisture than the sapwood that surrounds it, so vertical connectors funnel the moisture directly into the heartwood accelerating decay. Once the moisture content exceeds 22%, timber consuming fungi are activated and the decay process begins. Refer to Figure 3-2 for a detailed description of how and where the decay occurs due to these vertical bolts.

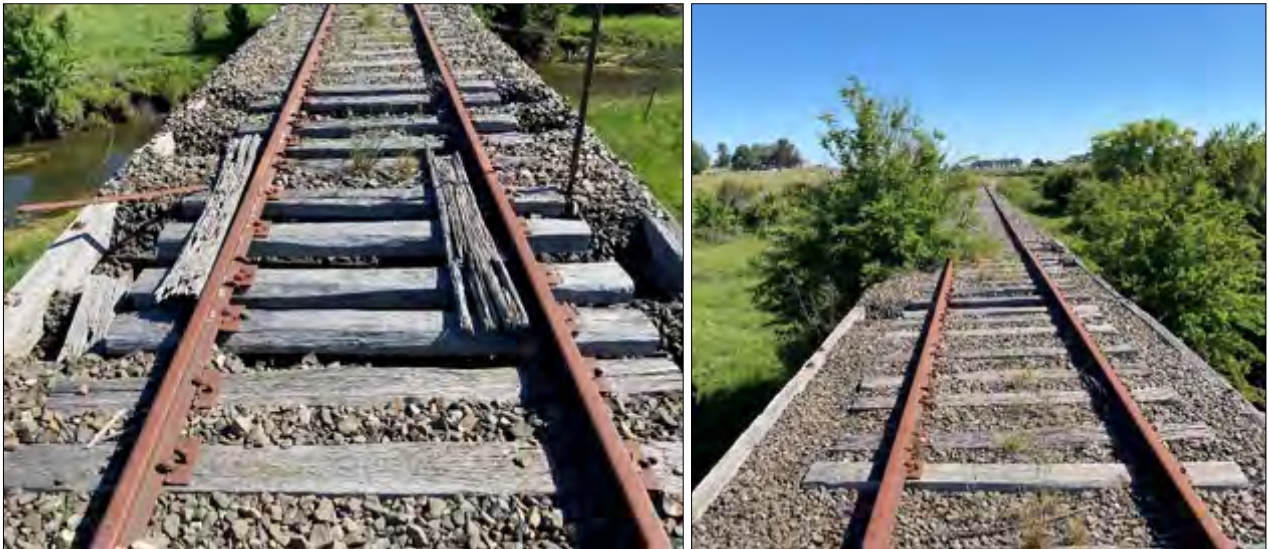
**Figure 8-5:** The timber transoms (rail ties) were found to be in a poor condition. If the bridge was to be repurposed for pedestrian and cycle use the timber transoms, railway line and rock ballast would be required to be removed. The existing timber edge rail that contains the ballast can left in place to act as a kerb/kick rail in the re-purposed bridge. To meet the current standards and Australian codes; vertical balustrade panels and a 1.4m high cycle rail will need to be installed. The current width of the bridge from inside of kerb to inside of kerb is approximately 3.0 metres which will result in a code compliant width for pedestrian bridges. As many of the deck planks are ‘falling’ out a new deck would be required for this bridge. The rock ballast can be reused to create the trail.

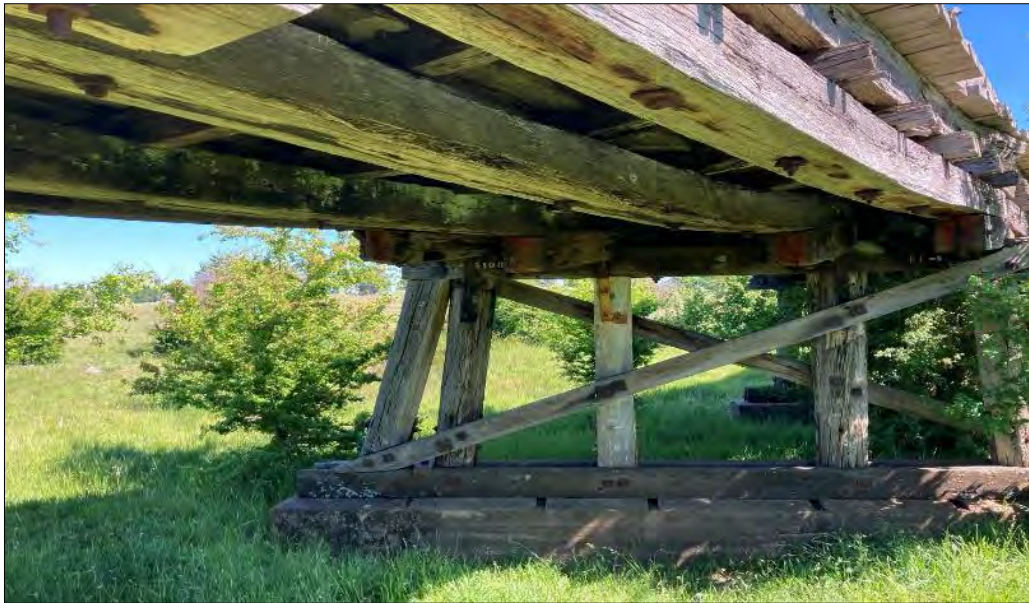
**Figure 8-7:** A view of a section of the bridge that has collapsed/sunken at Span 11. These members will require replacement before the bridge can be reopened for pedestrian and cycle use. The superstructure comprises of 4 girder lines per span with the 2 girders per a girder line (8 girders per span in total). The double stacked girders are separated by traverse beams that contribute to the load sharing ability of the superstructure.

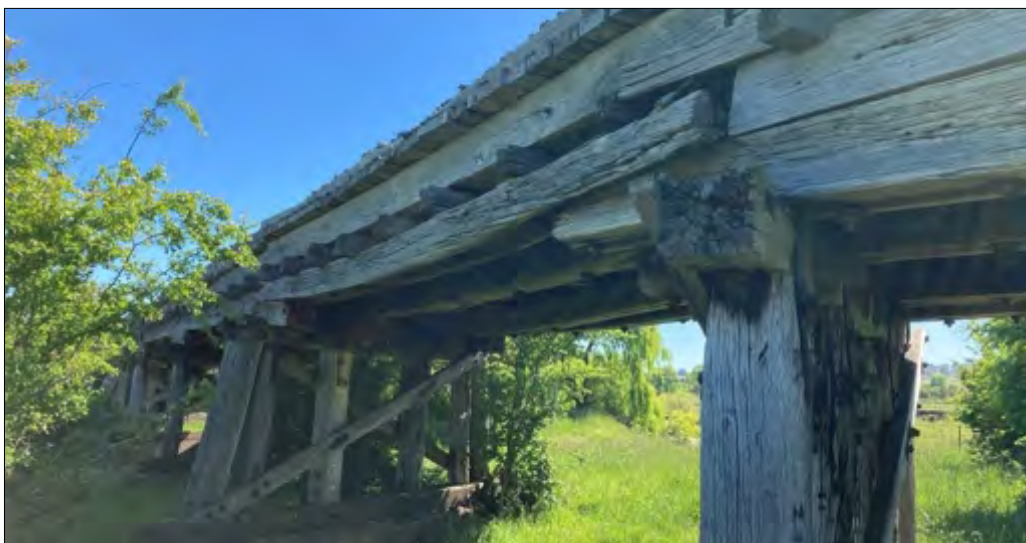
**Figure 8-8:** Another view of a section of the bridge that has collapsed/sunken due to the girder and corbel 'crushing' due to significant decay. The girders and corbels are connected down to the cap with a vertical through bolt. Vertical fasteners increase the rate of decay in timber as they allow moisture to travel down the fastener into the heartwood of the girders and corbels where evaporation is more difficult, therefore increasing the moisture content in the middle of these elements over longer periods of time. The heartwood of a large dimensional element is less capable of breathing and expelling moisture than the sapwood that surrounds it, so vertical connectors funnel the moisture directly into the heartwood accelerating decay. Once the moisture content exceeds 22%, timber consuming fungi are activated and the decay process begins. Refer to Figure 3-2 for a detailed description of how and where the decay occurs due to these vertical bolts.

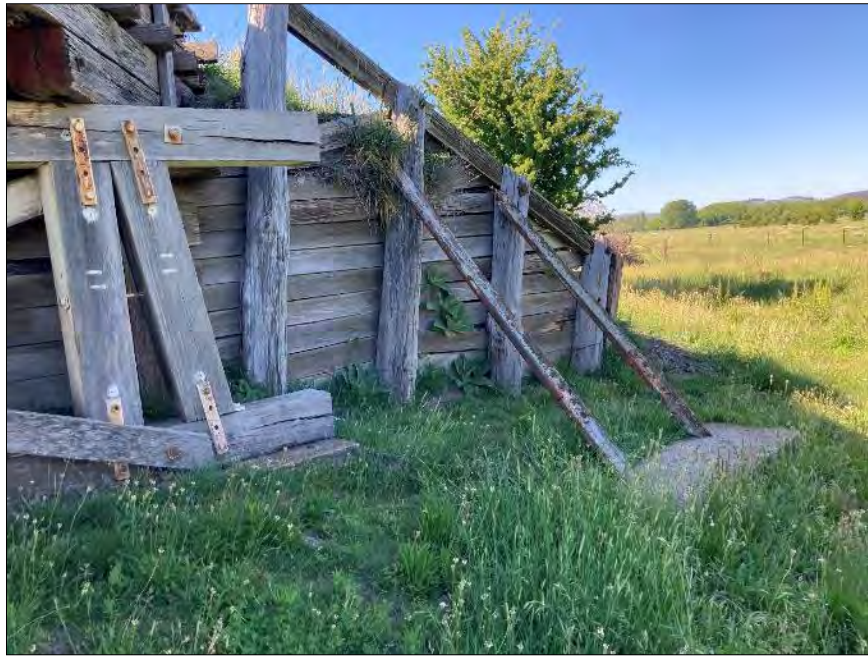
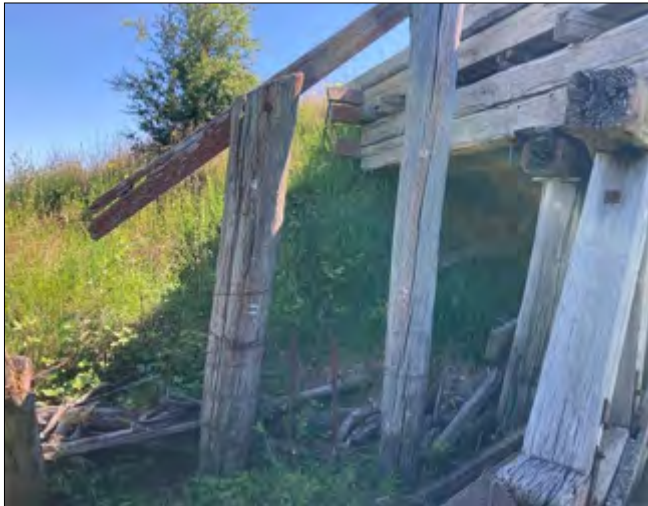
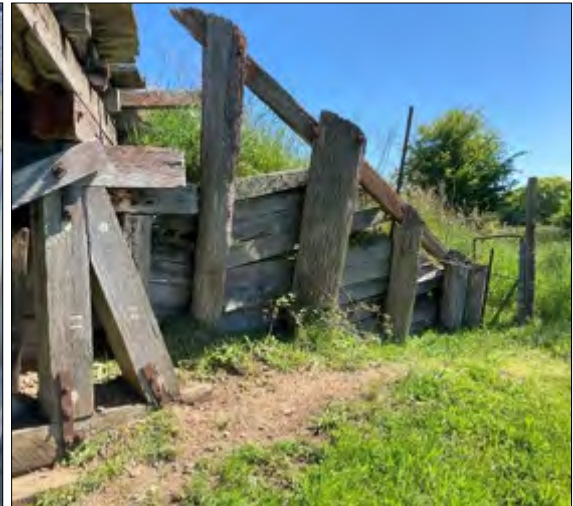
**Figure 8-9: View of the typical abutment wingwall configuration and condition. The timber breastwall and wingwall planks have undergone significant deterioration and are now leaning ‘outwards’. There is a loss of fines and larger aggregate from the approach through the breastwall. The top image is Abutment 1 with the bottom image Abutment 2.**

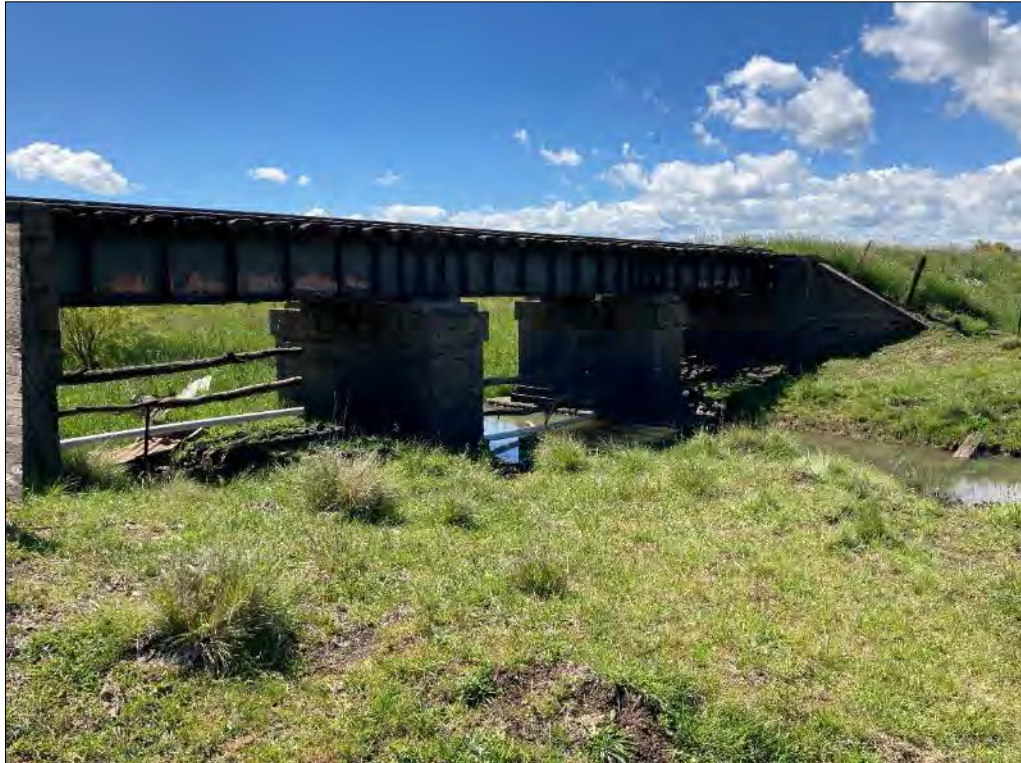
**Figure 9-1: View of Stonehenge Creek Bridge from Abutment 2 end of the bridge. Abutment 1 (Southern end) is to the right side of the image above. The natural flow of the creek is through span 2 with no water flow at the time of inspection. The configuration and current condition of the bridge is similar to Upper Williams Creek Bridge with the brick pier(s) however the girders are steel plated which is very common for railway bridges. The steel girder bridge is only 3 spans long and approximately 18 metres in length. The bridge piers can be saved for aesthetics.**

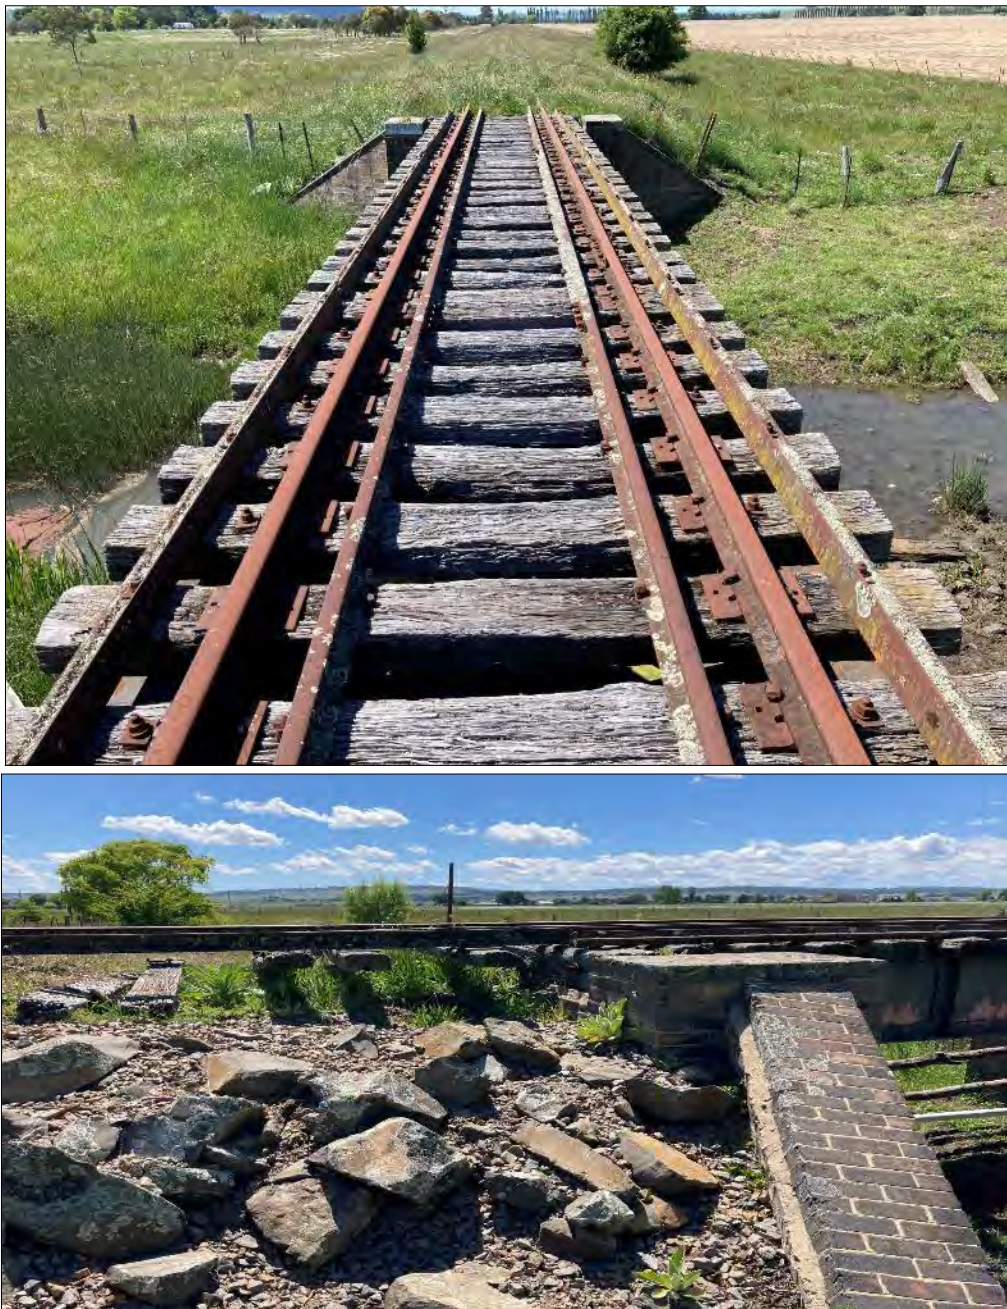
**Figure 9-2:** The top image is a view of the bridge looking back towards Armidale. The timber transoms are connected directly to the steel plated girders. There has been erosion/scour at Abutment 2 with many of the transoms missing and large amounts of approach fill missing. Notice the inner guard rail is still intact!!

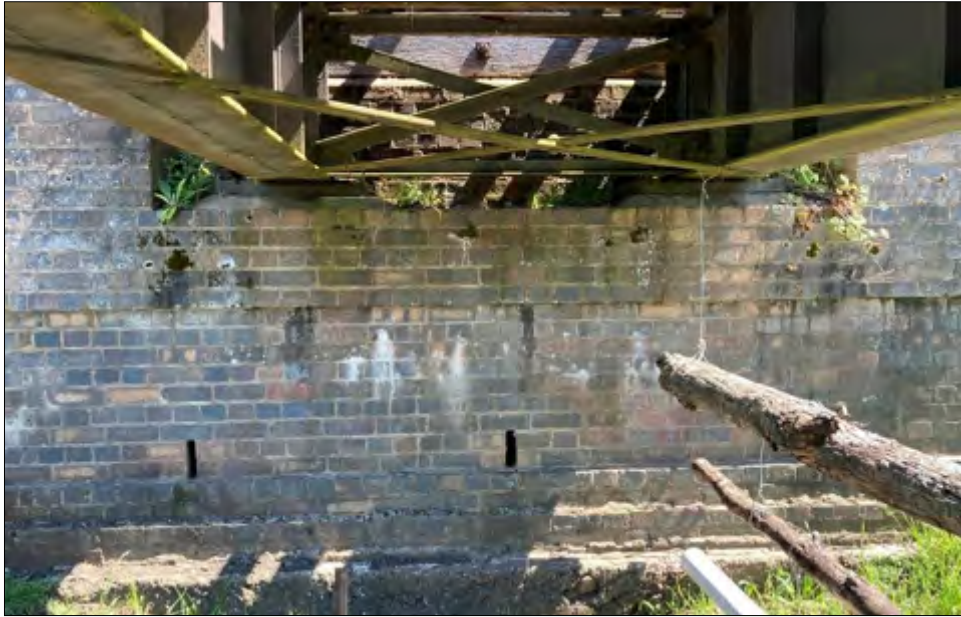
**Figure 9-3:** View of the brick Abutment that is approximately 3 metres in height. The steel plated girders bear directly on the brick pier. The girders are lateral supported by transverse and diagonal bracing. The substructure can be preserved.
