# New England Rail Trail

## Trail Development Plans

Armidale – Black Mountain  
Ben Lomond – Glen Innes

## DRAFT REPORT

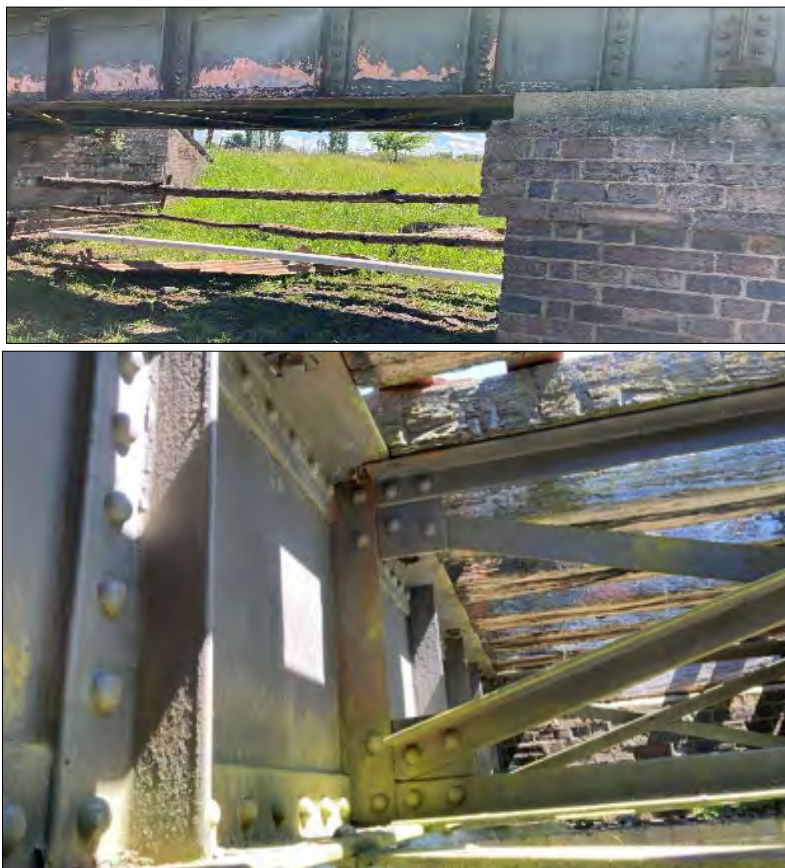
**Figure 9-4:** The steel is starting to show signs of corrosion with maintenance required for the steel plated beams. A lightweight deck system on-top of the girders will be the recommended repair solution for this bridge combined with steel repairs.

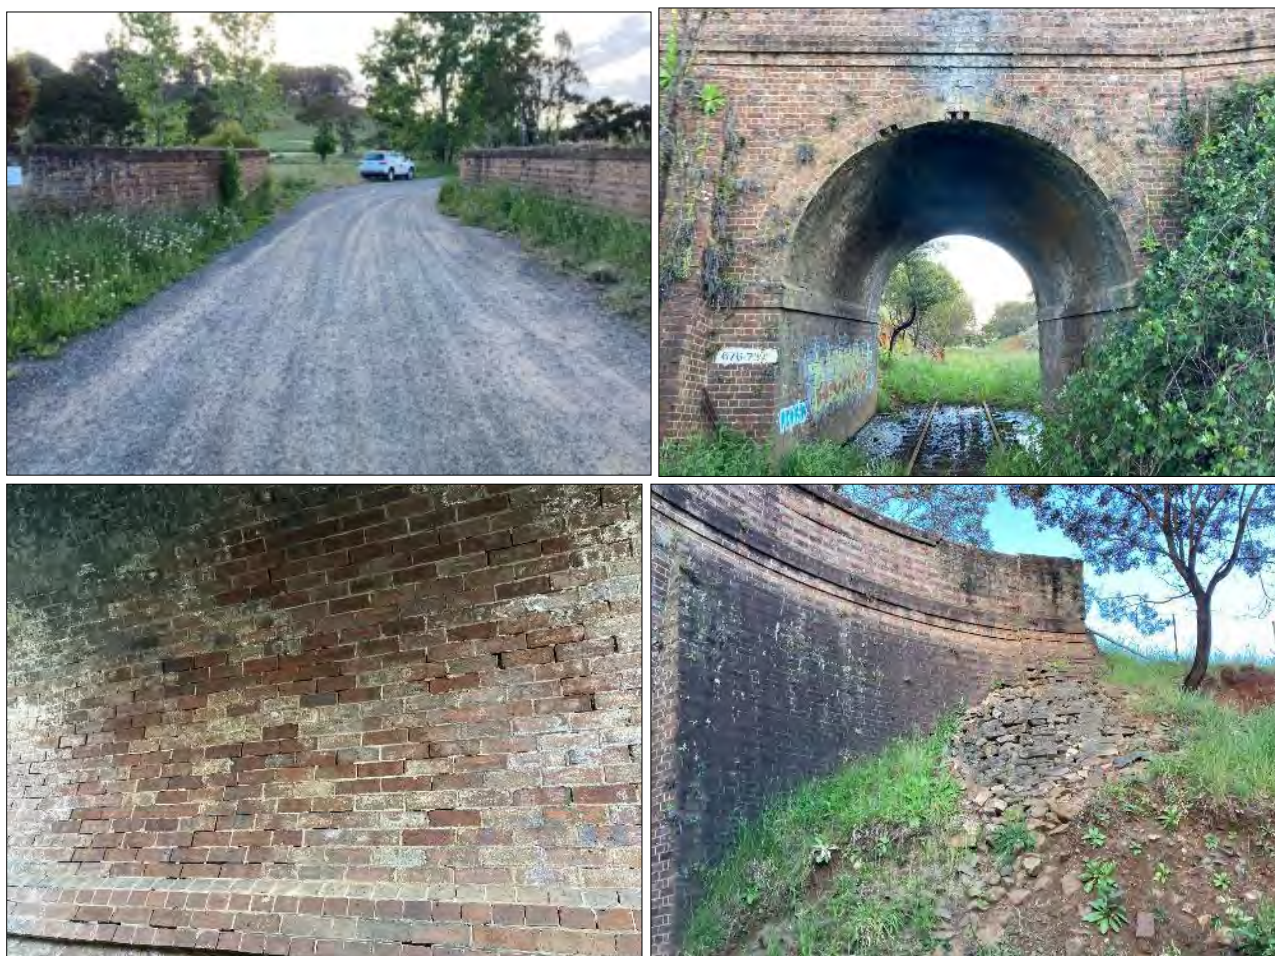
**Figure 10-1: View of Crotty Road brick arch overpass bridge. This bridge is located just off the New England Highway and can be a major attraction to the trail given its historic features. The archway under the bridge is in fair to poor condition and with minor maintenance can be restored to accommodate pedestrians walking through.**

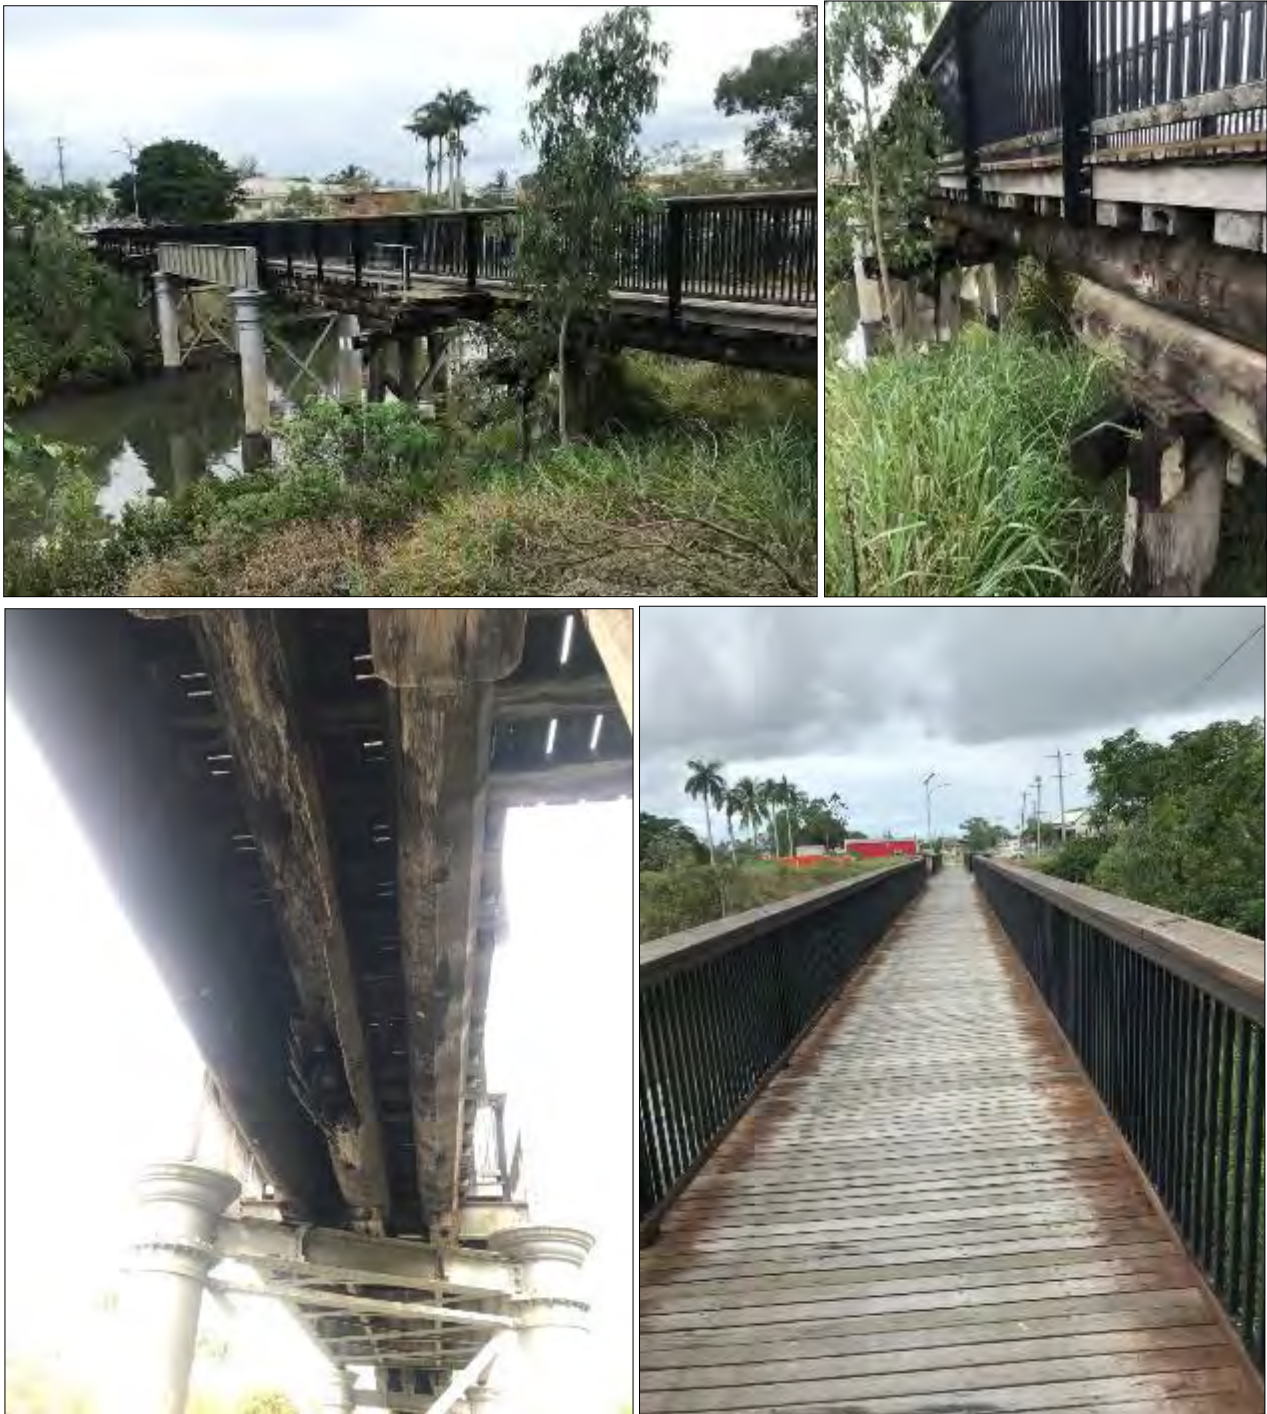
**Figure 11-2:** The above photo series demonstrates a similar repair to the option explored but deemed not viable for this rail trail. The existing railway bridge was left un-touched and a new hardwood deck system with handrails was installed. Six 100mm x 250mm timber joists were placed on top of the existing transoms (rail ties) with a 38-50mm thick hardwood deck installed on top. This option will likely be the lowest cost but also carries the shortest expected lifespan. As seen in the bottom left photo above, one of the girders has failed and fallen out creating a ‘weak’ point along the bridge. Due to a high residual capacity of timber and the continuous joists, a complete failure of the bridge (span) hasn’t occurred yet but is only a matter of time unless extensive maintenance is undertaken.
