# New England Rail Trail

## Trail Development Plans

Armidale – Black Mountain  
Ben Lomond – Glen Innes

## DRAFT REPORT

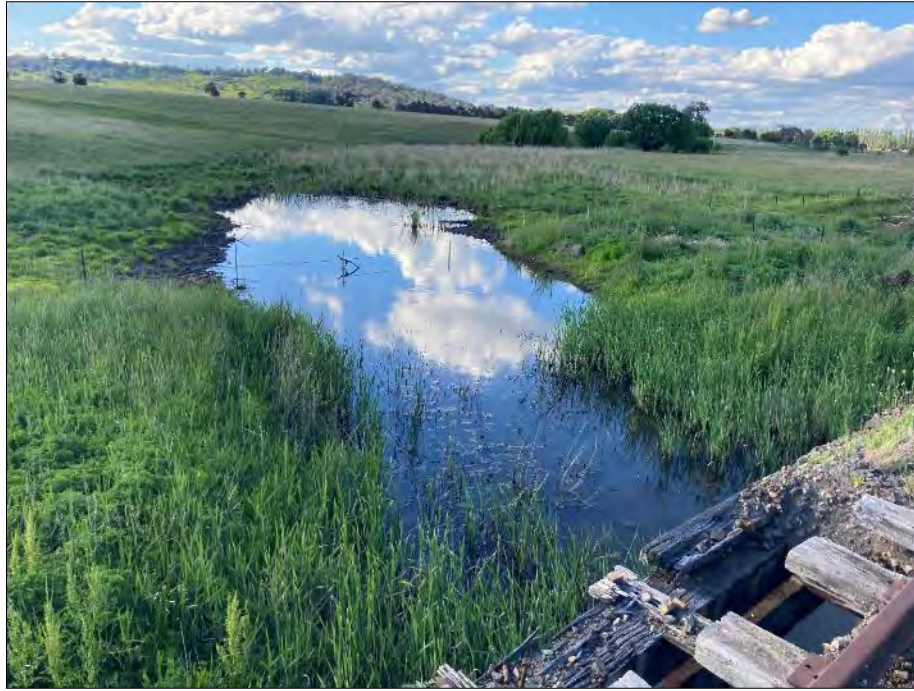
**Figure 7-6:** A view of the creek downstream. At the time of inspection the water was not flowing.

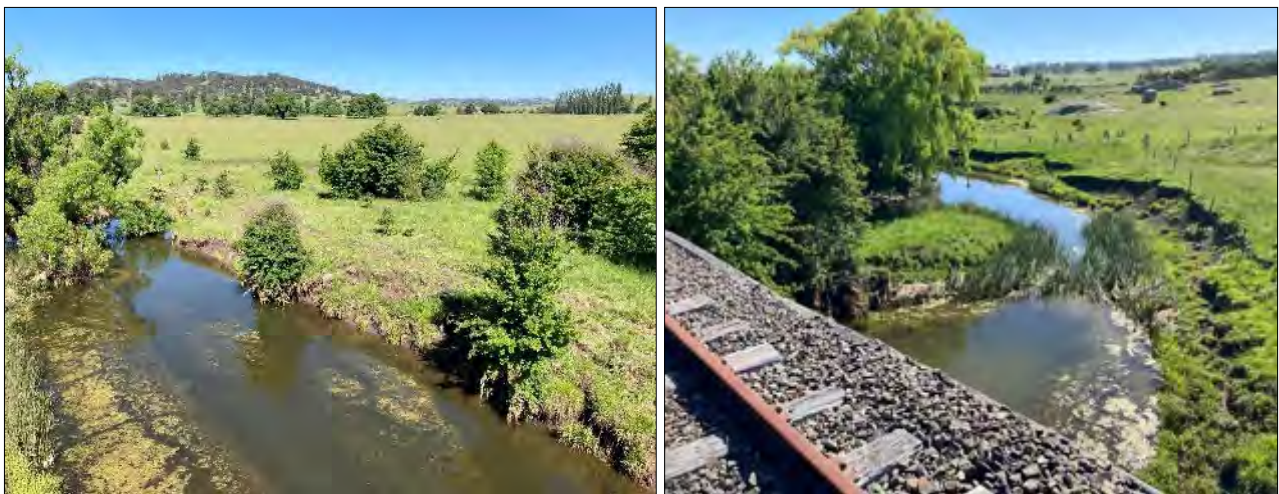
**Figure 8-6:** View of the stream upstream (left hand image) and downstream (right hand image).

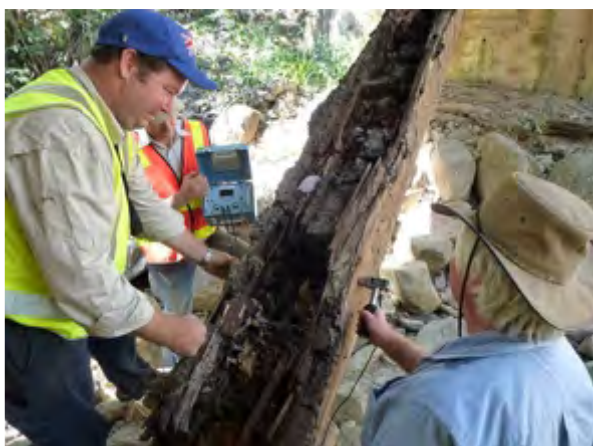
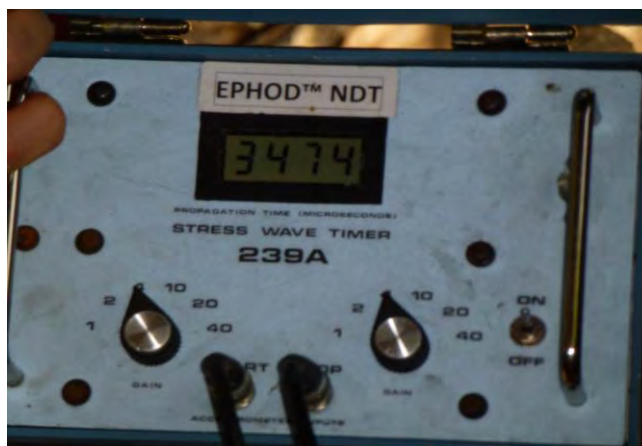
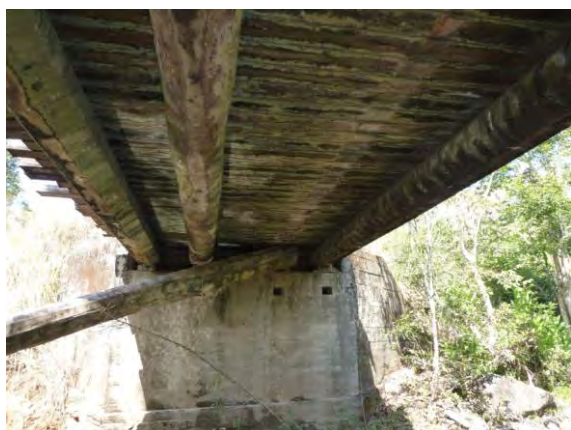
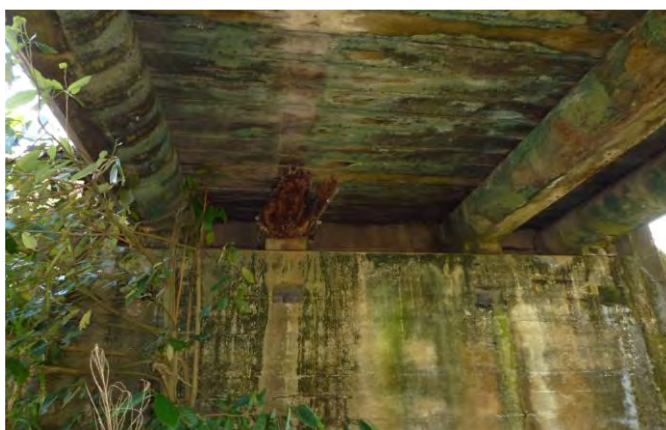
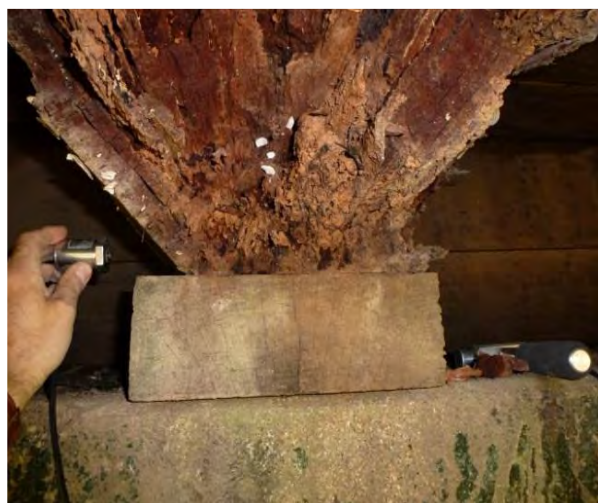
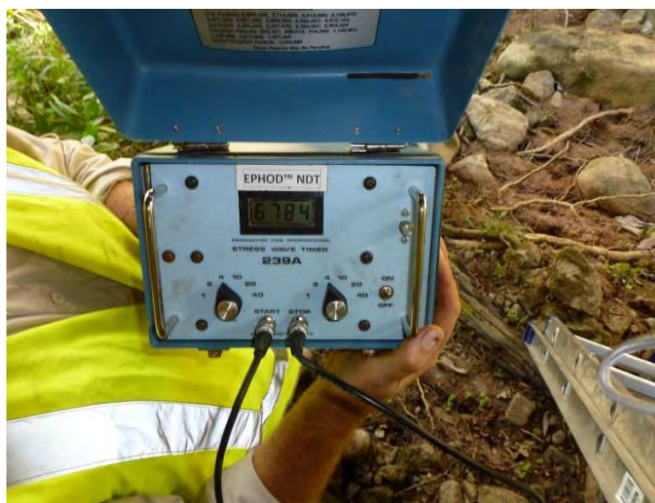
**Figure 11-1: Photos showing global failure of a timber log girders. Both failures were caused by advanced decay in the ends of the girders and transverse shear failures. The primary cause of this decay was due to vertical fasteners. These failures were found in elements with SWT values in the 3k  $\mu$ s (photos a. above) to 6k  $\mu$ s range (photos b. below). Typically similar bending extreme tensile fibre failures in log girders occur in zones of decay where there are over 2k  $\mu$ s SWT values. Similarly if vast portions of the log girder have SWT values over 3k  $\mu$ s the failures may occur.**

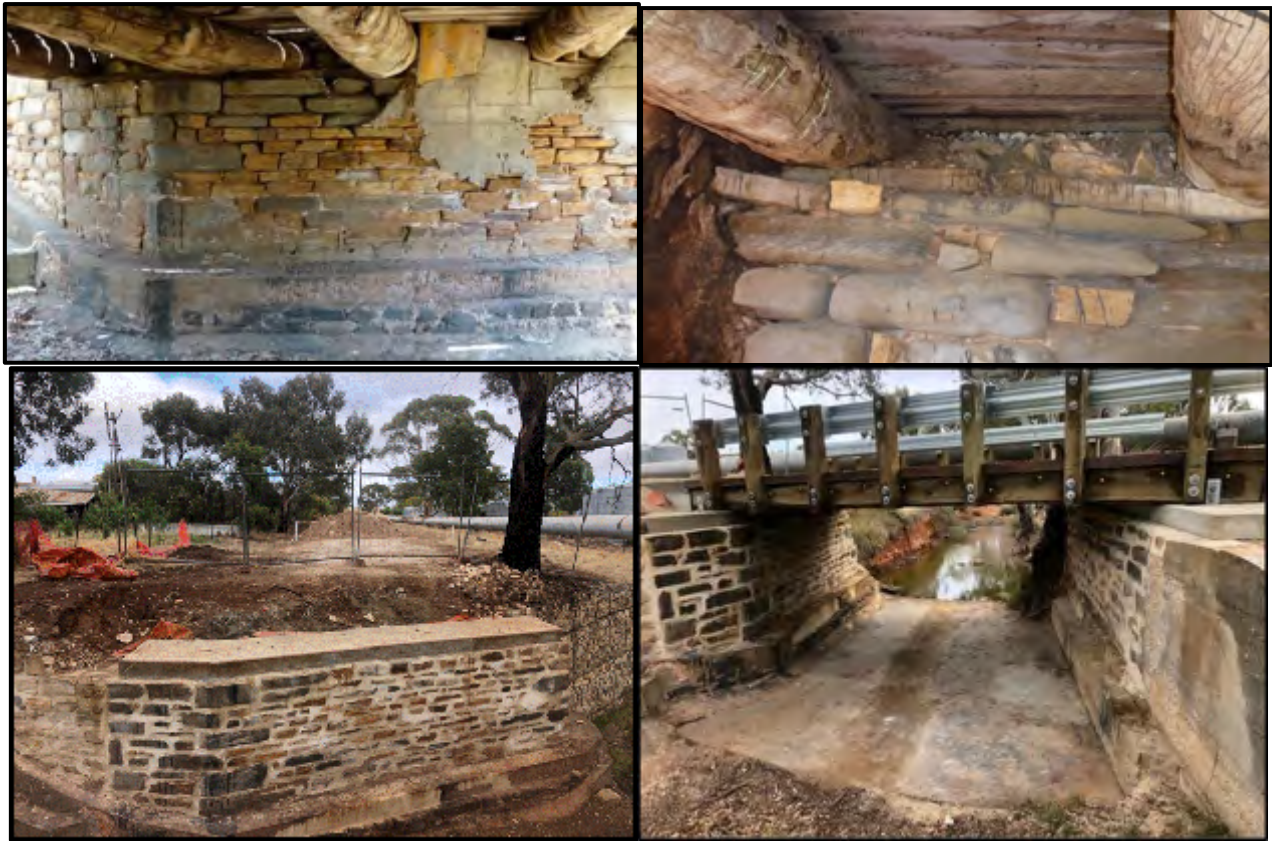
**Figure 11-6: The brick abutments and the hardwood deck and girders at Shannon Road Bridge were in very poor condition with major refurbishments required. The abutment wall was repaired where the mortar was missing due to weathering and scour. The abutment wall was levelled off in preparation for a loadbearing sill pad for the girders. Once the abutments were repaired a new hardwood girder and deck system was lifted into position and the bridge now has a load rating of 15 Tonne.**

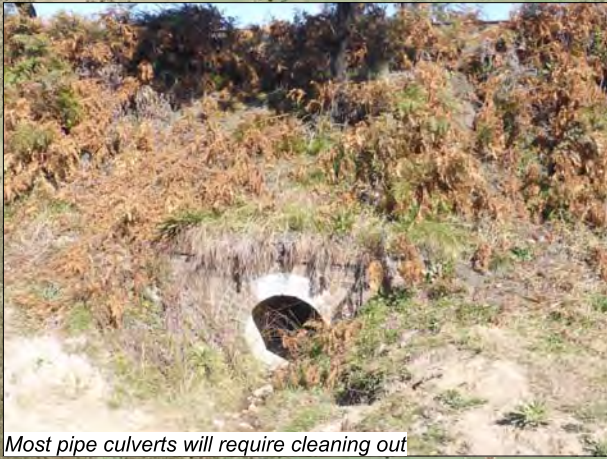
Most pipe culverts will require cleaning out

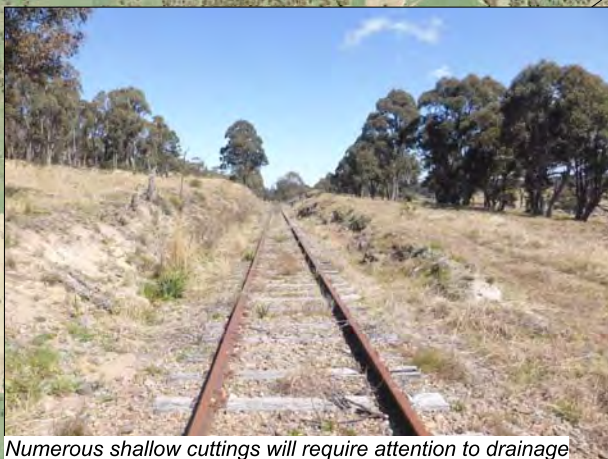
Numerous shallow cuttings will require attention to drainage

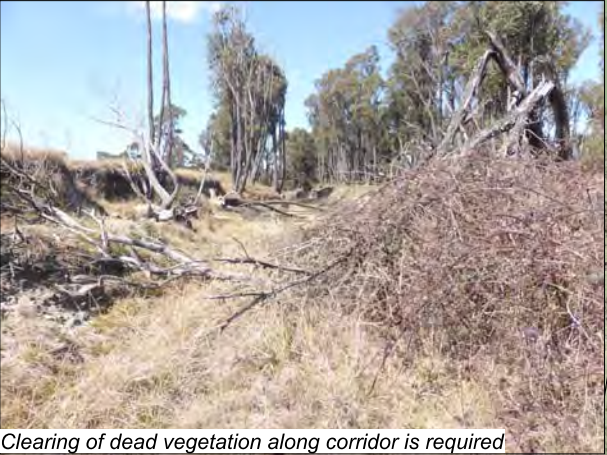
Clearing of dead vegetation along corridor is required

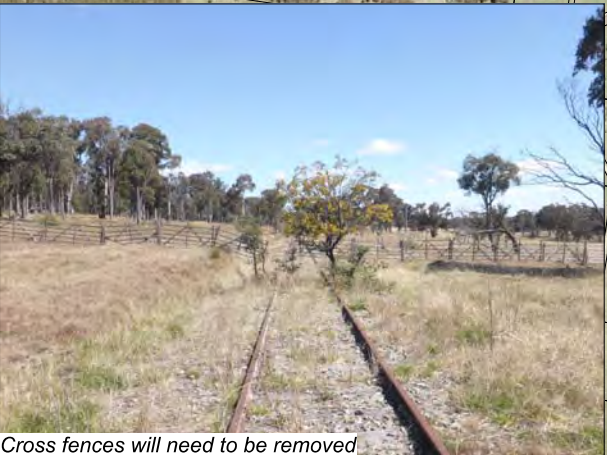
Cross fences will need to be removed

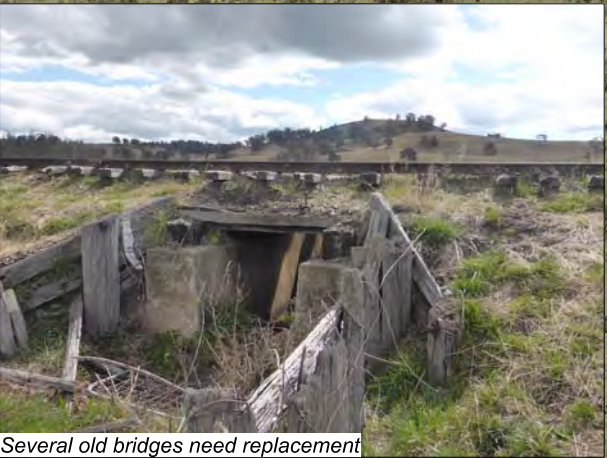
Several old bridges need replacement

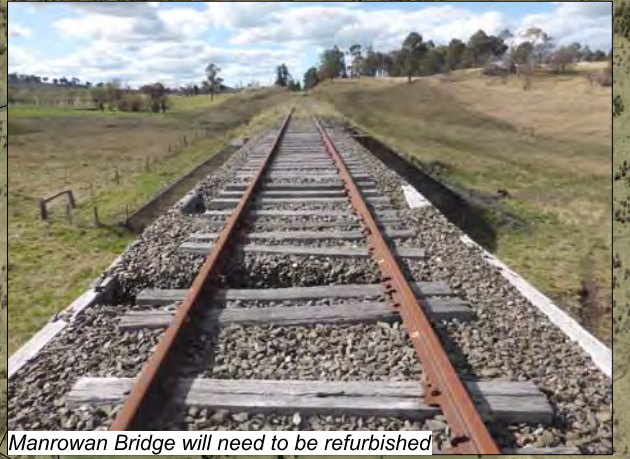
Manrowan Bridge will need to be refurbished

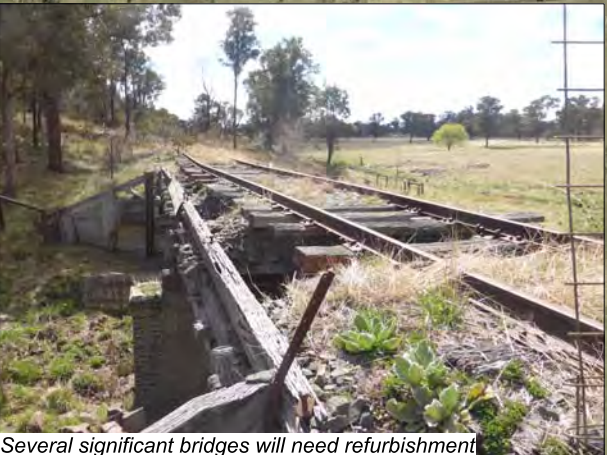
Several significant bridges will need refurbishment

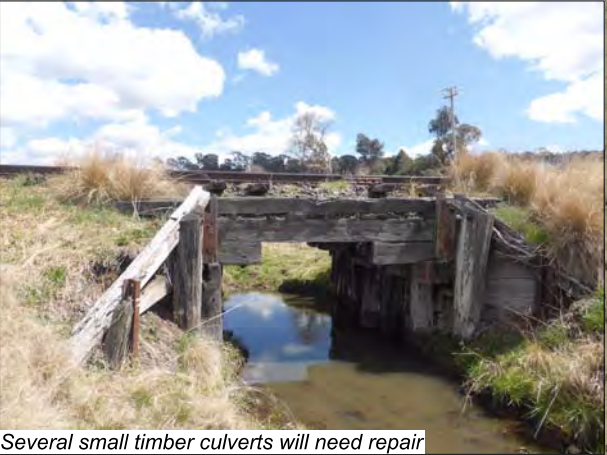
Several small timber culverts will need repair
